FLEXICLAD Repairs Cavitated Pump in Puerto Rico

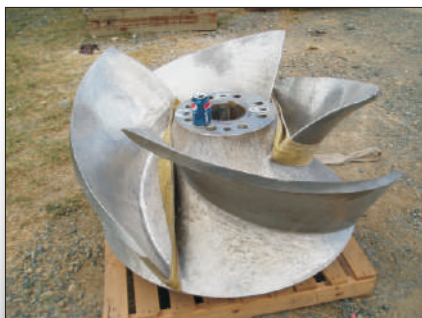
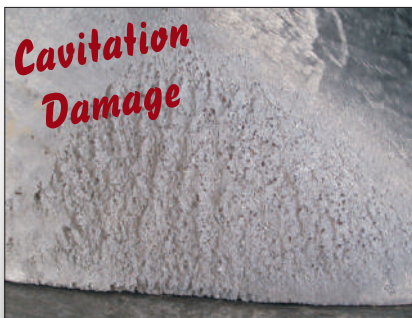
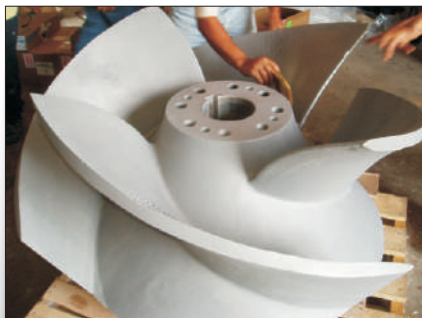
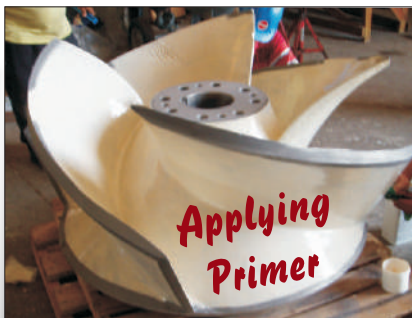
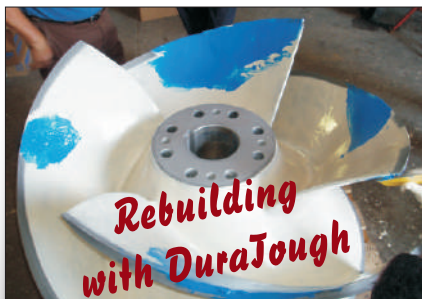
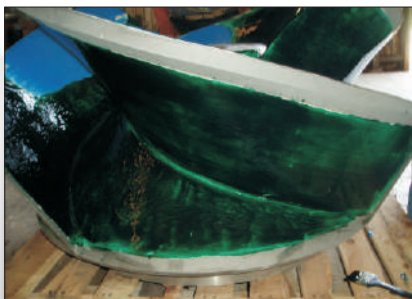
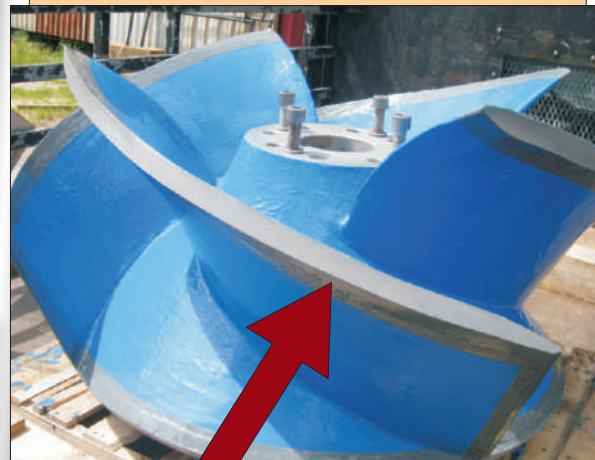
The stainless steel impeller of this large pump, located at a waste water treatment facility in Puerto Rico, was suffering from severe cavitation. The facility engineers needed a fast, reliable as well as cost-effective repair. The local ENECON Distributor was contacted to help find a solution.

The impeller was then protected from future cavitation damage with **DuraTough DL**.

In addition, **CeramAlloy CL+AC** was also used to protect the impeller's edges. **CeramAlloy CP+AC** and **CL+AC** were also used to rebuild and protect the pump casing which had significant corrosion damage.

It was decided that the impeller would first be prepared by grit blasting, followed by all cavitated areas being rebuilt with **DuraTough DP**.
