Repair & Protection Of Split Case Pump With CeramAlloy & CHEMCLAD

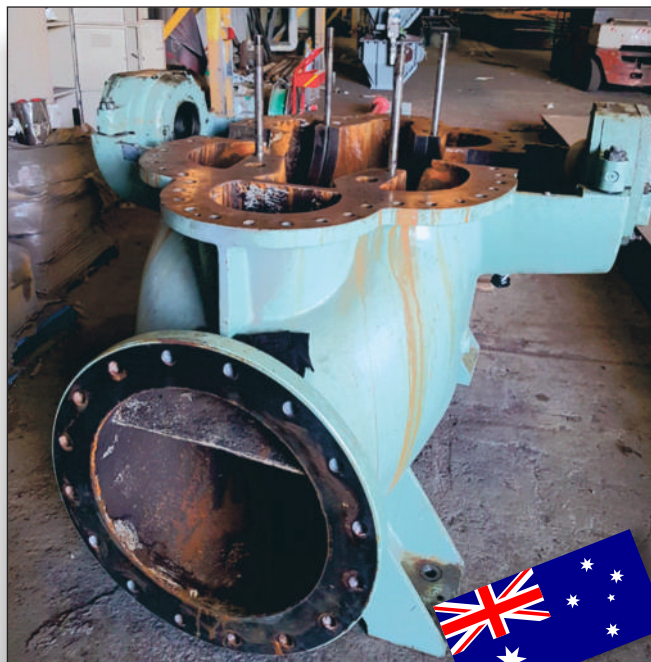
When this split case pump, at an Australian regional water authority, was removed from service for maintenance, it was discovered that the internal coating was failing. This led to the exposure of the pump's substrate to corrosion. Also, there was a visible crack in the pump lid.

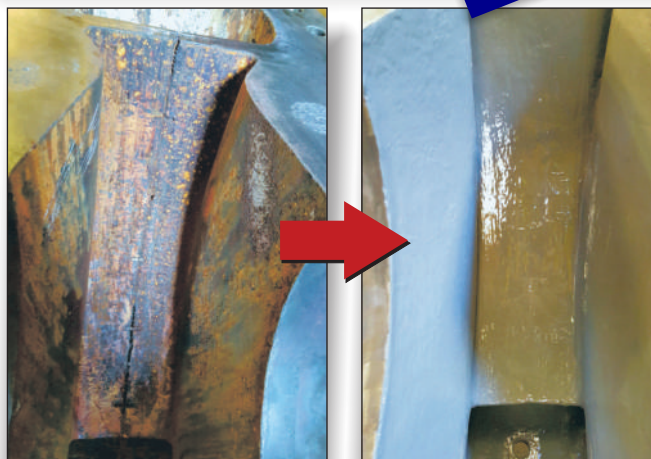
The flange surfaces were protected with tape in order to insure there was no damage during the two phase abrasive blasting surface preparation. The first phase revealed substantial corrosion damage.

The pump was left wet for 24 hours to allow impurities to leach from the blasted substrate. The pump was then

abrasive blasted a second time with angular steel grit to achieve a class 3 level of cleanliness and a profile of 75 microns. The first layer of CeramAlloy CP+AC was then applied using a trowel and brush.
