Municipal Pool Selects DuraQuartz Lightweight & ENESEAL HR For Overhead Concrete Repairs

Location: Municipal pool located in eastern U.S.

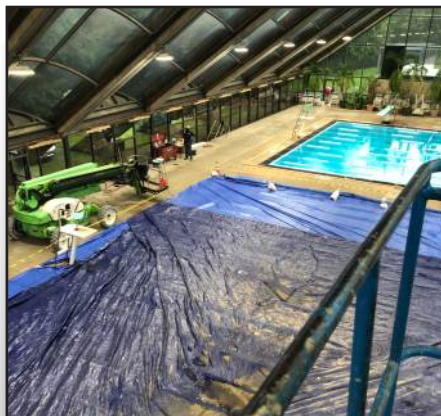
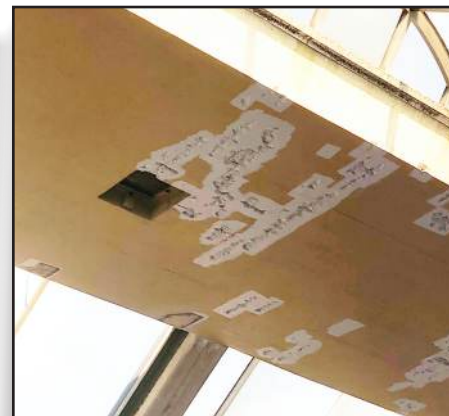
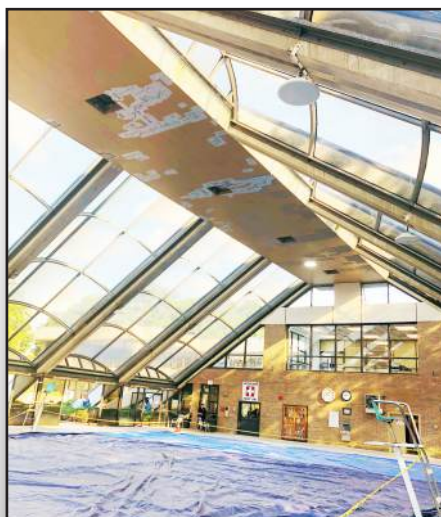
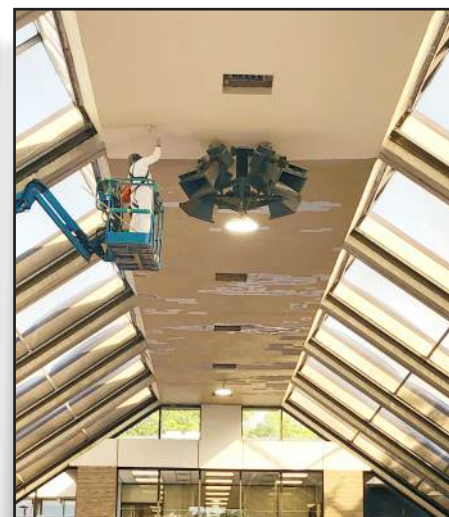
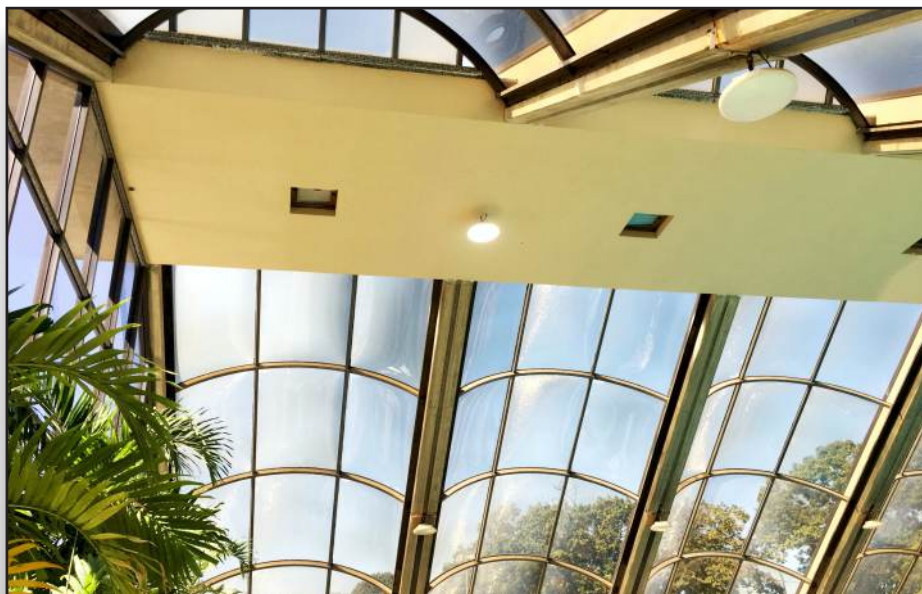
Problem: After years of leaking windows & skylights, the overhead concrete ceiling of this indoor pool building began to crack and spall. The potential for concrete chunks to fall into the pool while it was in use was a serious safety concern of the pool maintenance team.

Solution: The pool was first protected with tarps. Under the tarps were pieces of foam to prevent the tarps from sinking during the concrete preparation.

The concrete was prepared by manually chipping away any loose concrete near the cracks. The prepared areas were then primed and DuraQuartz LW was used to make the repairs. After the repairs were made two coats of ENESEAL HR were then applied.
