Australian Gold Mine Turns to CHEMCLAD & CeramAlloy to Save Pump Operating in 15% Hydrochloric Acid!

These photos are of a pump from a gold mine which was repaired by an ENECON Fluid Flow Systems Specialist in Australia.

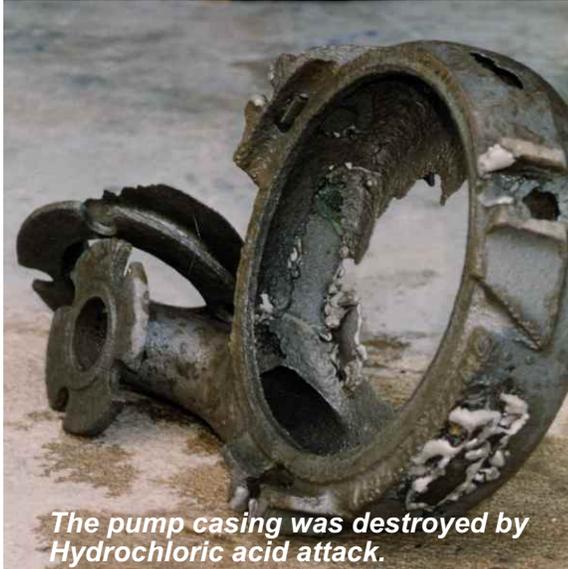
The pump casing was destroyed by Hydrochloric acid attack.

The pump was running in 15% Hydrochloric acid and, as you can see, it has been attacked from the outside as well as the inside!
