ELECON REVS

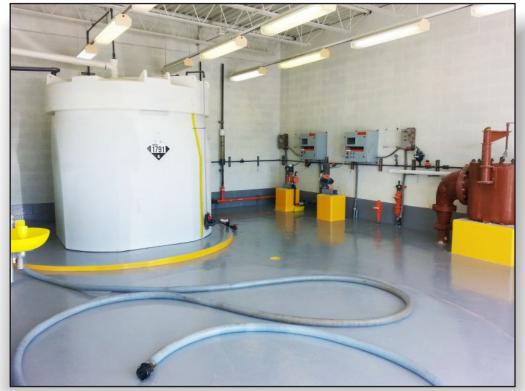
The floors of this Florida canal pump station were severely degraded. Brackish canal water is mixed with 12% sodium hypochlorite and reclaimed wastewater to create water that is used for much needed irrigation in the area.

After preparing the surfaces and removing all of the loose concrete, the degraded areas were repaired with DuraQuartz. CHEMCLAD P4C was used to prime the entire area, then CHEMCLAD SC was used to provide chemical resistant properties to this floor.
