Florida Water Authority Stops Leaking Pump Well Head With DuraFill & Passes State Inspection

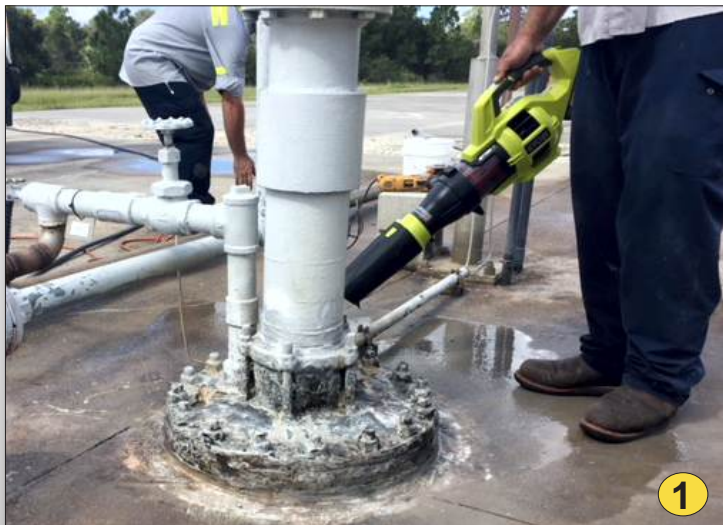
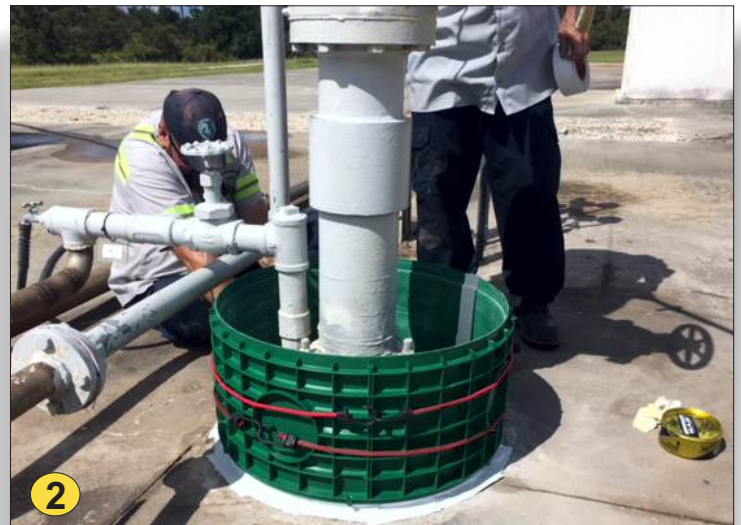
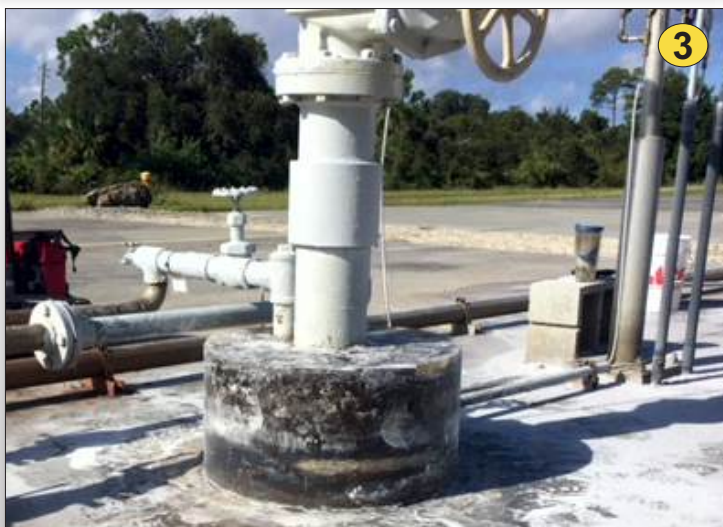
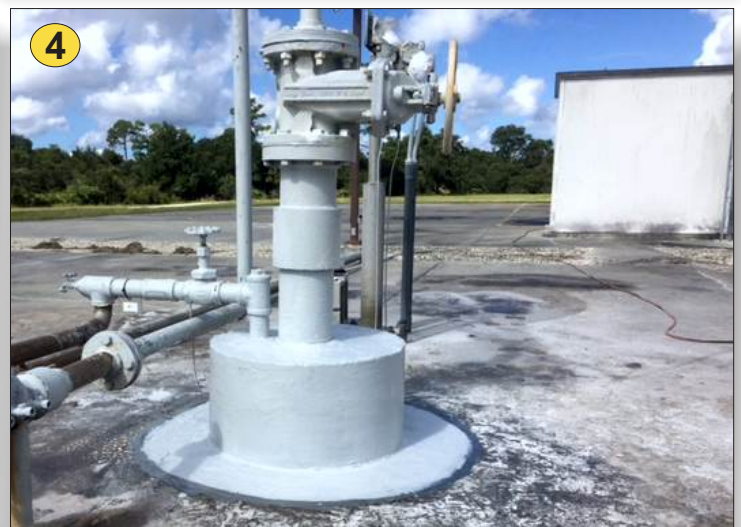
This south Florida water authority needed a repair solution for a broken and leaking pump well head. An upcoming inspection by state officials at the facility, to ensure a mandated zero leakage policy, was taking place in

one week. A replacement head would take 8-10 weeks and cost over \$60,000. If a repair solution was not found, the water authority would have to shut that part of the plant down and also face potential fines.

The local ENECON Field Engineering Specialist suggested encapsulating the pump head in DuraFill because of its unique adhesion and compressive strengths.

A cylindrical former was made and the area was cleaned. A release agent was used to coat the former and the DuraFill was mixed and poured in. The next day the former

was removed and the entire well head was coated with ENESEAL CR to protect the metal components as well as for aesthetics.
