## Canadian Steps Look Like New After DuraQuartz Repair

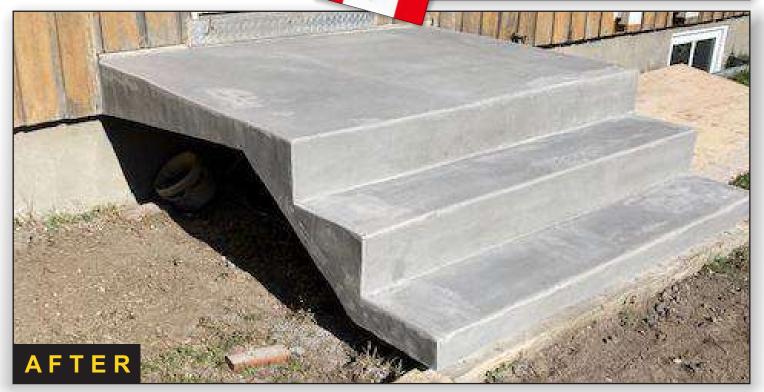
These concrete office entry steps in Canada were deteriorating due to years of snow accumulation, shoveling, salts and deicers, freeze/thaw cycles and general everyday wear.

2. Repair the steps in one day with ENECRETE DuraQuartz.

Wisely, the owner chose DuraQuartz as the solution to this problem because of its versatility, extraordinary adhesion, chemical resistance and outstanding compressive strength.
