DuraFill, DuraGrip & ENECLAD WBC Are All Used To Repair Damaged Staircase At Western U.S. University

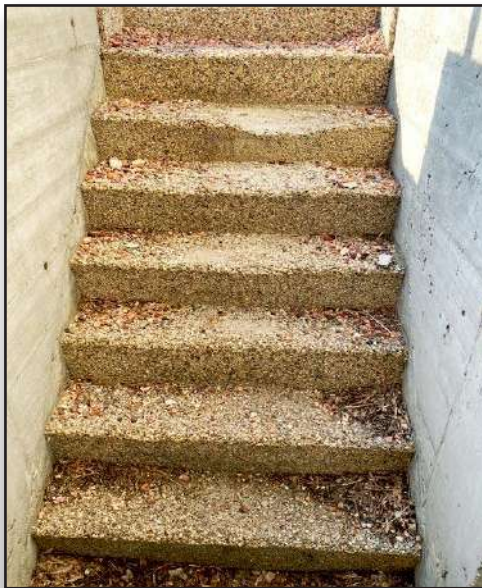
A western U.S. university had an outdoor staircase leading to a basement mechanical room that had fallen into disrepair. A previous attempt to repair the stairs had been made using an epoxy with an overlay of pea gravel. That repair eventually failed and the local ENECON Distributor was contacted and asked to help find a solution to this problem.

The first stage of this repair was to remove the failed pea gravel overlay and crumbling concrete to expose a solid surface below. The surface was then high pressure washed and degreased.

A form was built to the size of each step and *DuraFill* mixed with

approximately 500 pounds of locally sourced sand was used to rebuild the staircase. The steps were given a proper pitch for water runoff.

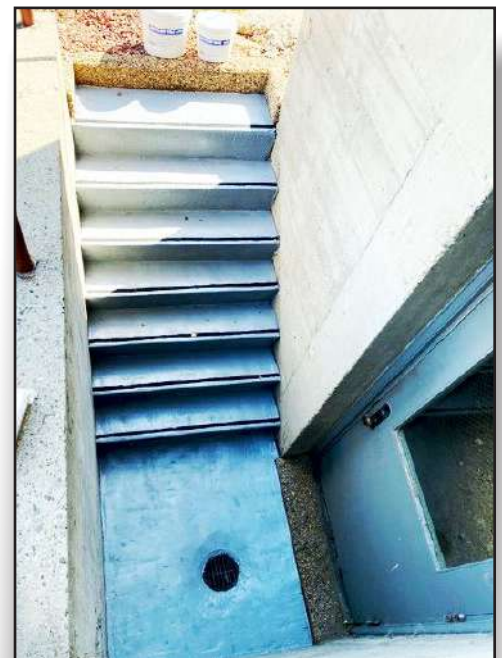
The university's facilities manager was very pleased with the results of this application. It served two purposes: the staircase is now aesthetically pleasing and it is no longer a potential safety hazard.

SuperBond and black aluminum oxide were used to create a *DuraGrip* strip on the front edge of each step. Then the entire staircase was coated in two coats of *ENECLAD WBC* with a backrolled aggregate to provide even more slip resistance.
