German Utility Company Repairs and Protects Cavitation Damage on Francis Turbine with CeramAlloy[®] & DuraTough[®]

Client: German Hydroelectric Plant.

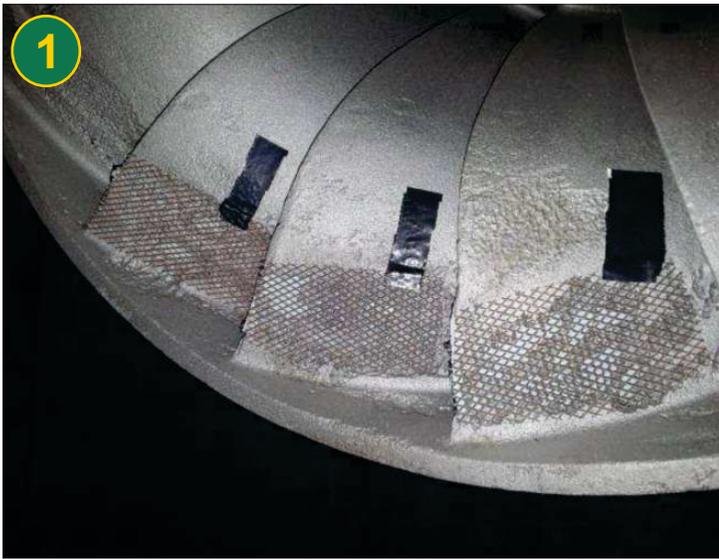
Problem: Francis turbine vanes were suffering from erosion and corrosion due to the effects of cavitation after the failure of a previously applied coating.

- 1. Steel mesh is welded to the vanes.**
- 2. CeramAlloy CP+AC covers the mesh repairs.**
- 3. CeramAlloy CP+AC rebuilds the vanes.**
- 4. The turbine is coated with CeramAlloy CL+AC.**
- 5. DuraTough DL provides the cavitation protection.**
