Severely Cavitated Turbine Shaft Repaired Using METALCLAD & DuraTough

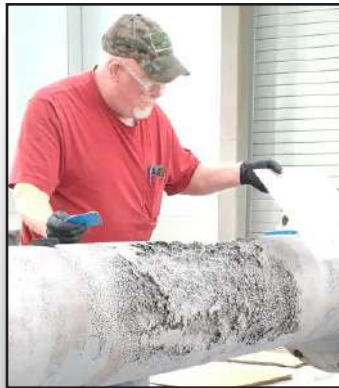
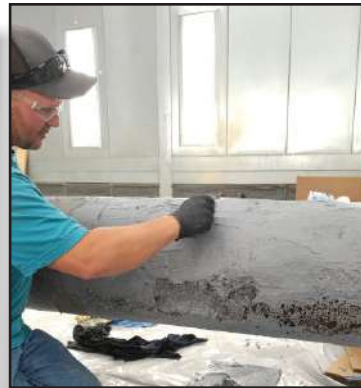
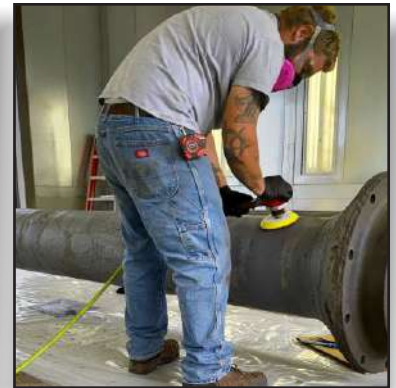
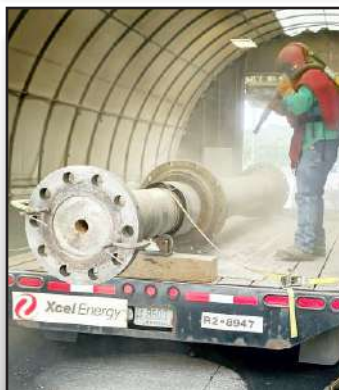
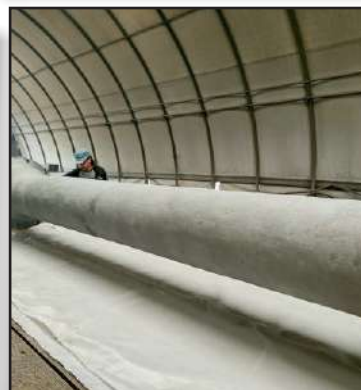
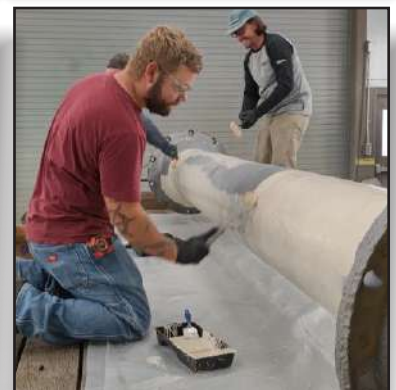
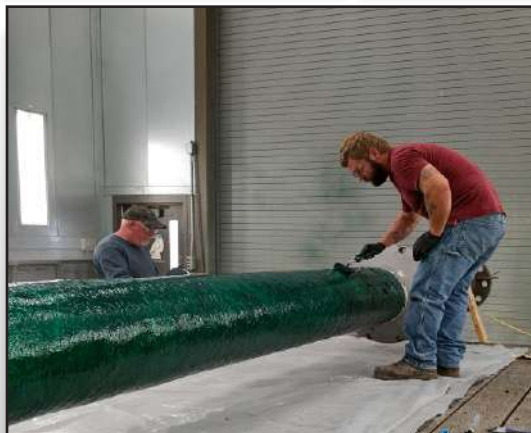
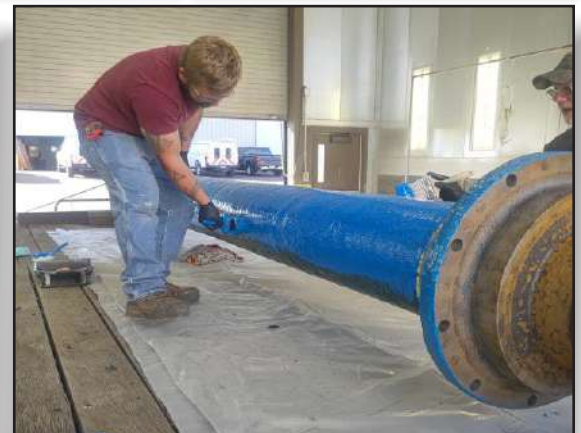
A turbine shaft at a utility in the midwestern U.S. was badly damaged by cavitation. The ENECON specialists in the area recommended a repair using both **METALCLAD DurAlloy** and **FLEXICLAD DuraTough**.

First the shaft was grit blasted, cleaned and repaired with **DurAlloy** to build up the diameter back to original size. The entire shaft was then brush blasted and coated with **DuraTough DL** to prevent future cavitation damage.
