**Client:** Waste water treatment plant.  
**Location:** Northeastern U.S.  
**Problem:** Corroded & leaking main influent pipe.  
**Solution:** Repair leaks with *DurAlloy*; reclaim pipe with *DuraWrap Carbon Fiber Pipe Wrap System*.  
**Cost:** \$40,000 total turn-key project.  
**Savings:** \$100,000+ replacement cost.

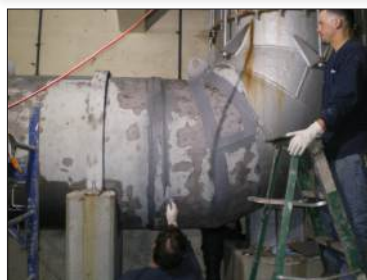
After grit blasting, leaks repaired with DurAlloy.

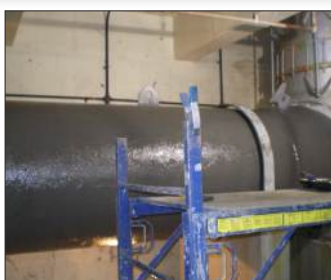
DuraWrap Primer applied.

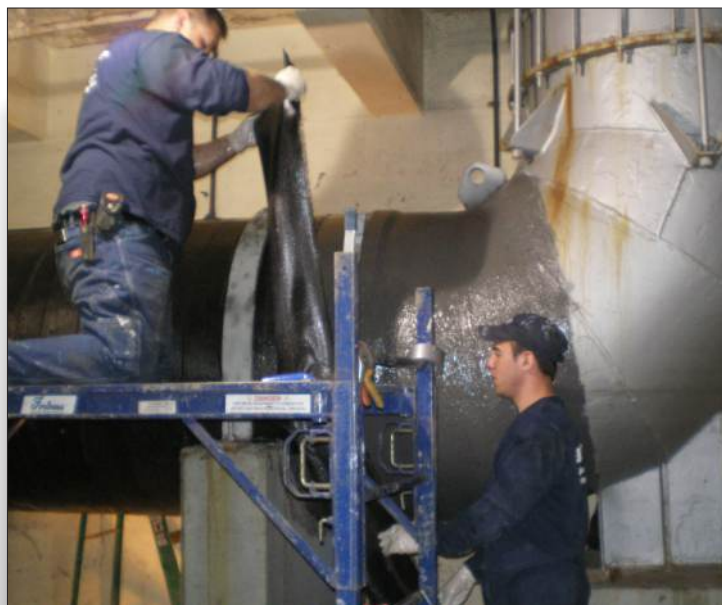
DuraWrap Carbon Fiber, impregnated with DuraWrap Polymers, being wrapped around pipe section.

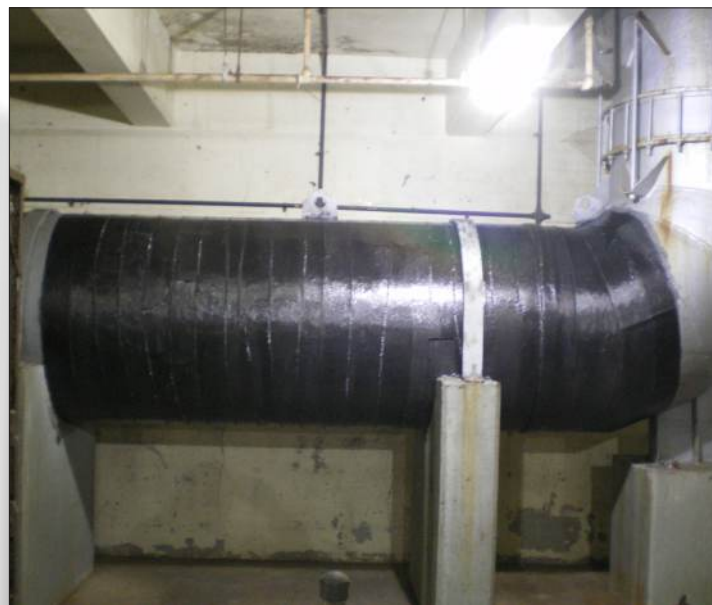
Completed DuraWrap System.
