Municipal Storm Water Drain Pump Repaired & Protected With CeramAlloy

ENECON® NEWS

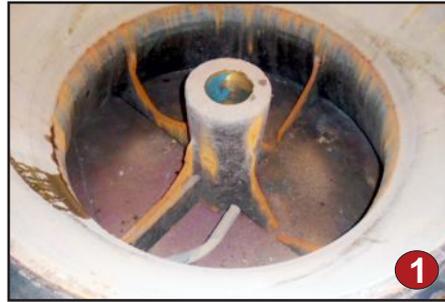
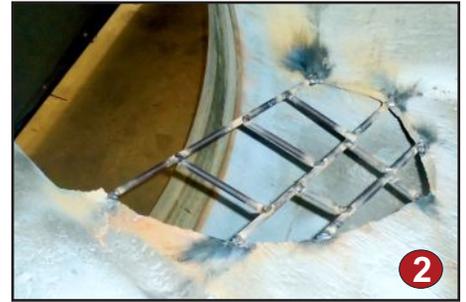
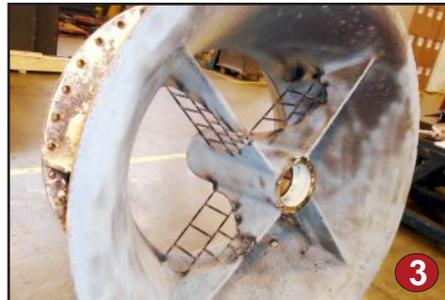
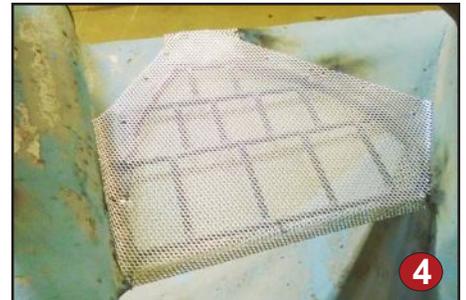
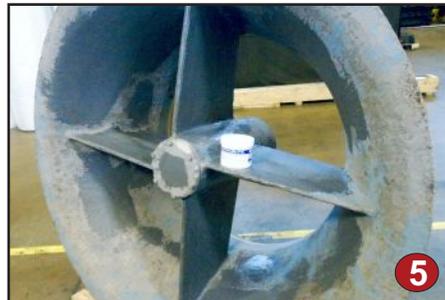
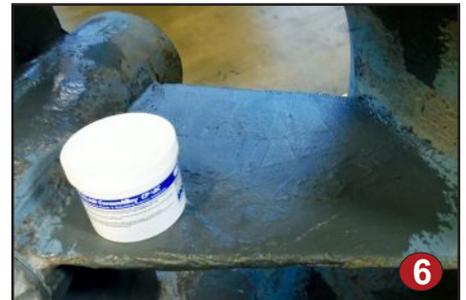
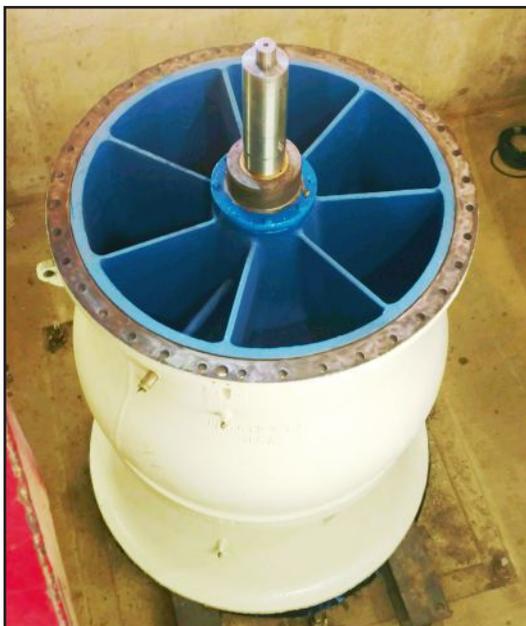
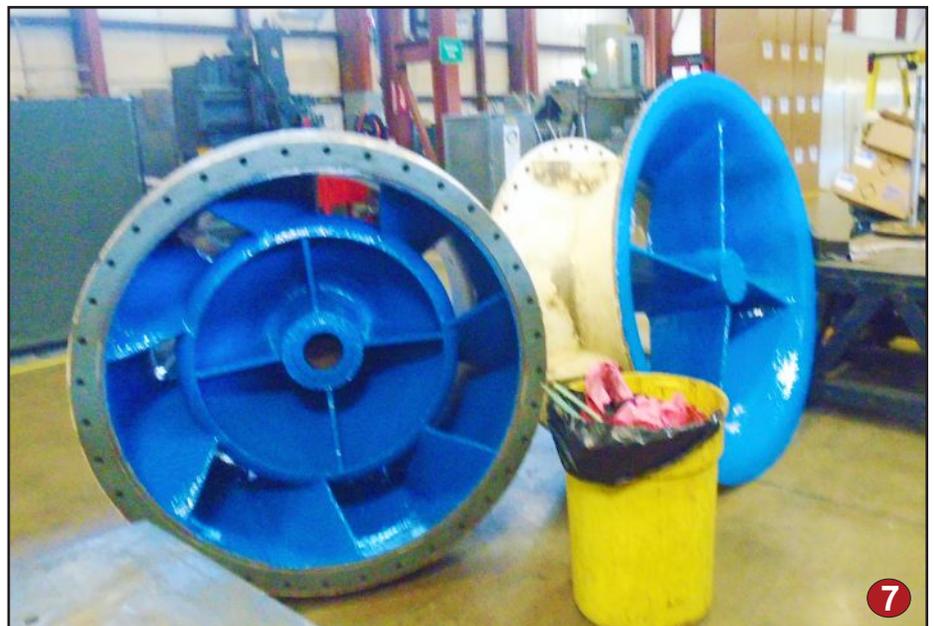
Problem: Debris such as sticks, trash and silt eroded this municipal storm water drain pump bowl's veins (pg.1). The debris also broke the impeller's veins (pg. 2).

Solution: A new 'skeleton' for the veins was constructed by welding metal bars and wire mesh. CeramAlloy CP+AC was used to rebuild the veins and CeramAlloy CL+AC protected all the internal pump surfaces.
