## Office Building Drain Pipe Repaired With DurAlloy & Protected With CeramAlloy

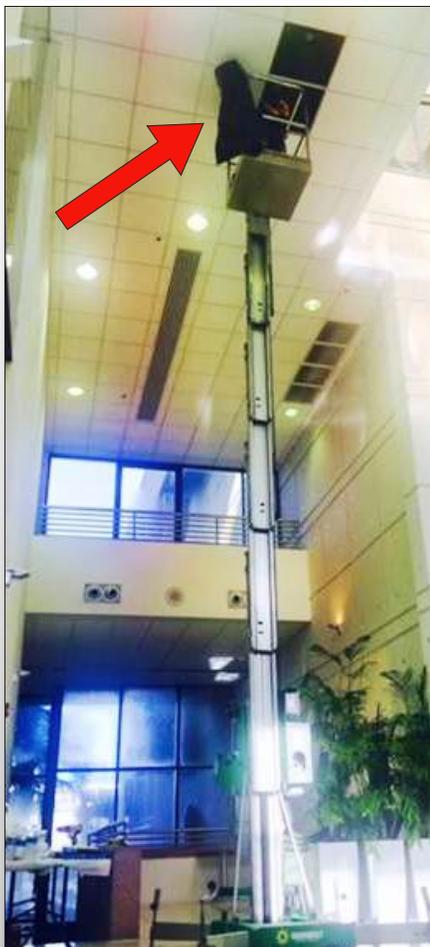
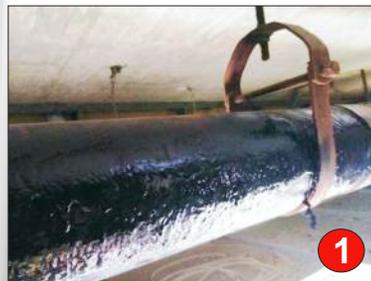
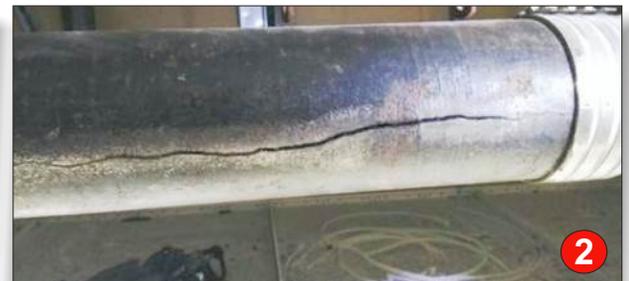
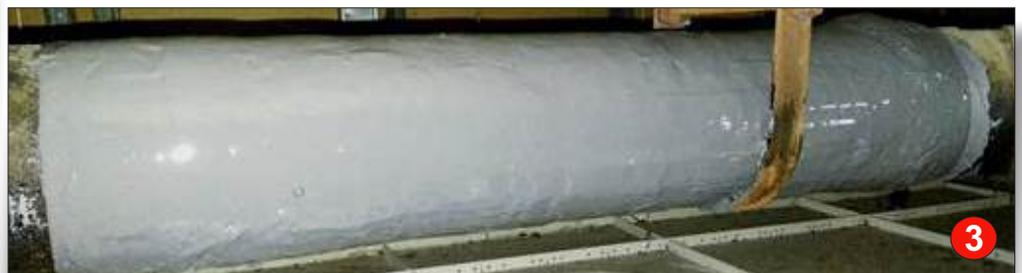
This eight inch diameter drain pipe was located thirty six feet in the air, behind a drop ceiling, in an office building lobby in southern Florida. The building's maintenance team found a three foot long crack in the pipe that was leaking.

Initially, the building's maintenance team used an aerosol spray-on flexible "rubber" repair material which quickly failed. A reliable, proven solution was needed fast. The ENECON Field Engineering Specialist was contacted and a new, trusted solutions was agreed to.

The flexible repair material and rust had to be removed from the pipe. The pipe was

mechanically ground to the appropriate profile. Then the crack was cleaned by using a small wire brush. The pipe was cleaned with denatured alcohol.

METALCLAD DurAlloy was used to repair the cracked pipe surface. Additional DurAlloy was then applied to the entire pipe followed by overlapping layers of reinforcing mesh to provide structural stability to the pipe. A third layer of DurAlloy was applied on top of the mesh.

Finally, METALCLAD CeramAlloy CL+AC gray was applied to the entire pipe to provide ultimate corrosion protection.
