## Pump Impeller Still Performing After 10 Years

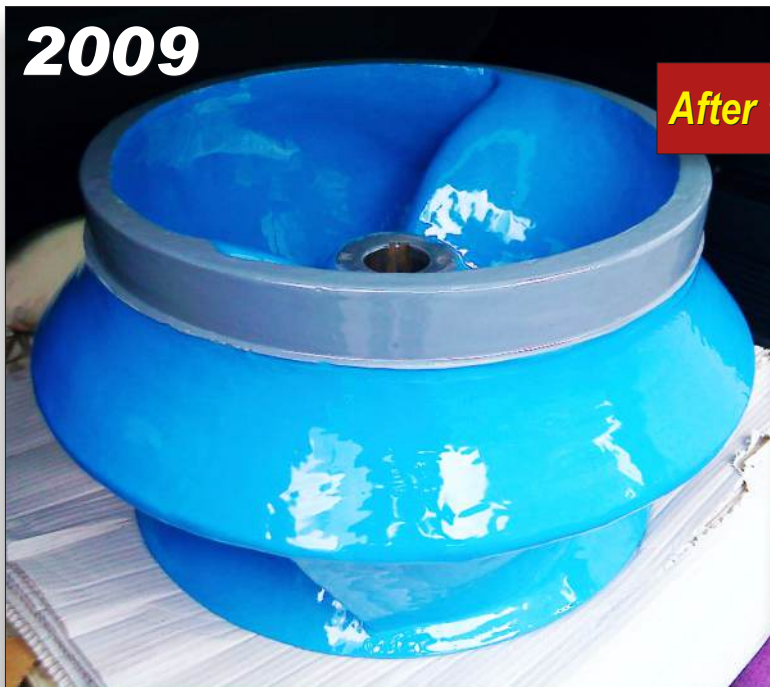
In 2009 this wastewater treatment plant channel pump impeller was headed for the scrap pile. ENECON Germany was contacted to provide a possible reclamation solution.

After abrasive blasting the impeller veins were repaired with sheets of metal welded in place. CeramAlloy CP+AC was then used to rebuild the shape and contour of the impeller.

A hand grinder was used to smooth the impeller's surface. Two coats of CeramAlloy CL+AC were then applied to provide the erosion / corrosion resistance necessary in

the wastewater environment.

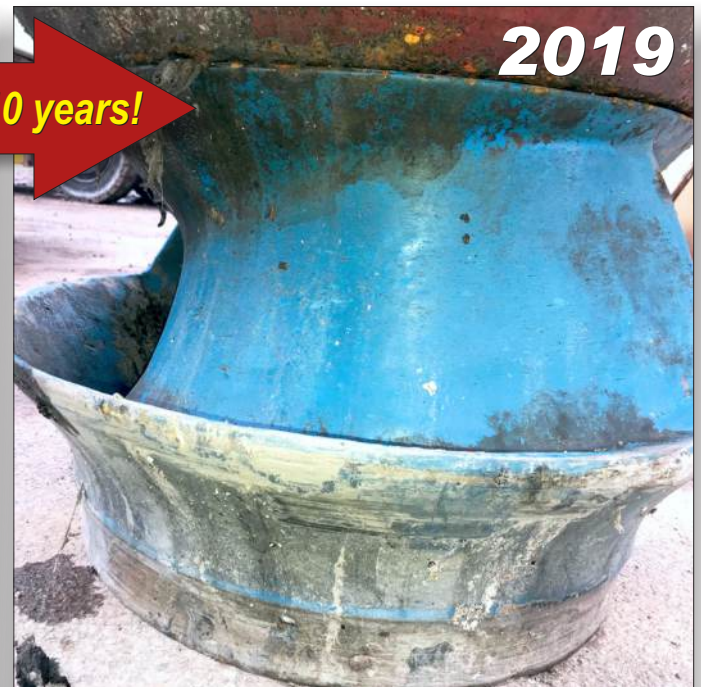
2019

After 10 years in service, the pump was dismantled during a shutdown. The impeller was inspected and only minor touch-up spot repairs were necessary.

After 10 years!
