## Severely Corroded Forty-Eight Inch Main Condenser Power Plant Intake Pipe Was Repaired With METALCLAD DuraWrap

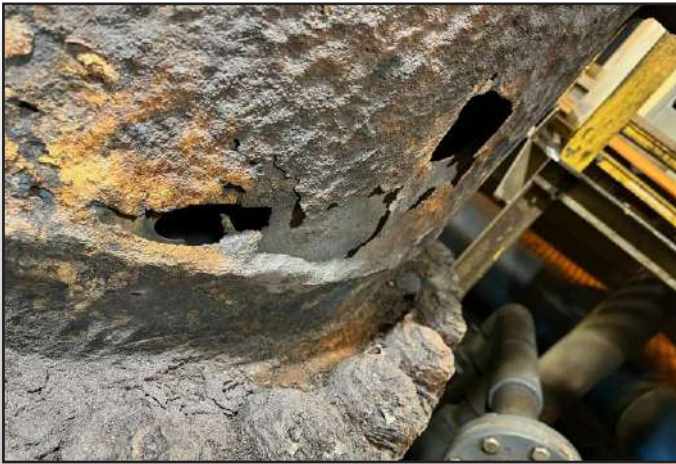
**Problem:** This 48" salt water intake line for a main condenser at a Northeastern U.S. power plant was severely corroded, and its structural integrity had been compromised.

Damage exposed after grit blasting.

The pipe was grit blasted and repaired by bonding and strapping a metal plate to its severely damaged areas with CeramAlloy CP+AC. The DuraWrap Primer was used to fill any surface imperfections. This process provided a smooth, stable surface to which the carbon fiber wrap could adhere.

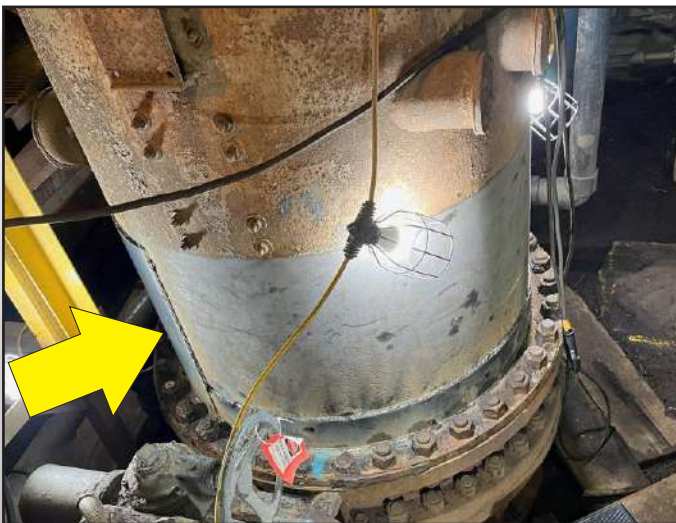
CeramAlloy CP+AC is used to bond the plate.

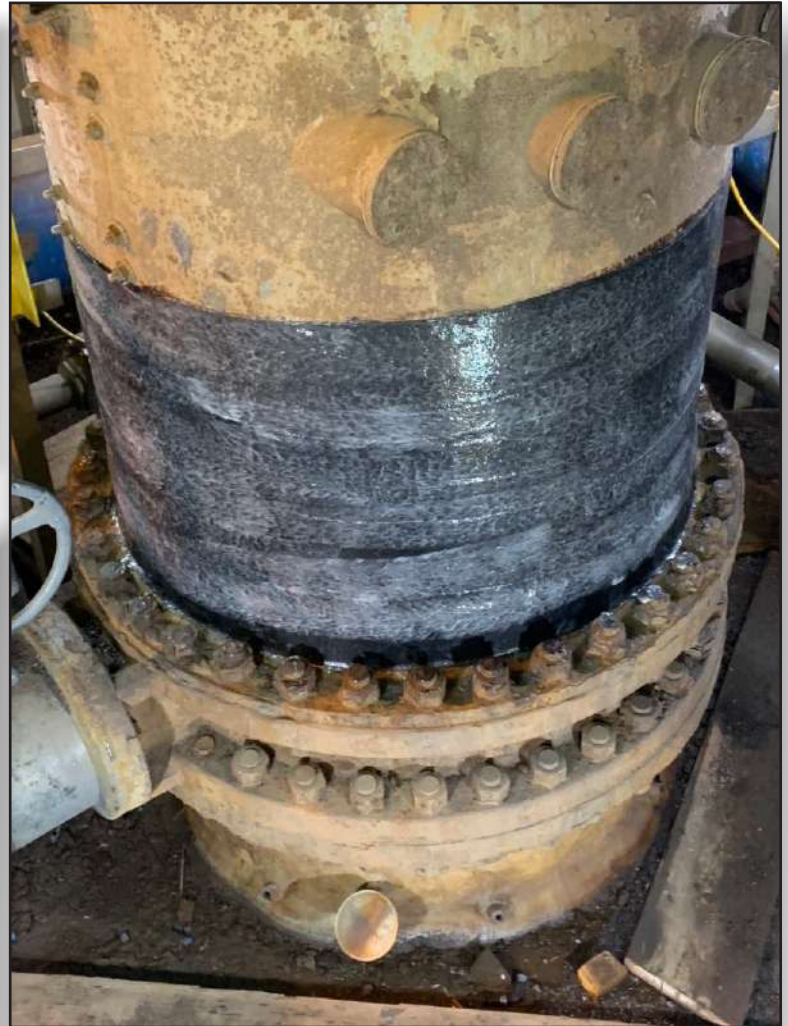
DuraWrap completes the repair.

**Solution:** After inspection by the local ENECON Distributor, a METALCLAD DuraWrap Carbon Fiber Pipe Wrap System was recommended for the repair.
