Educational Institution Repairs & Protects Mechanical Room Floor with SuperBond, DuraQuartz & CHEMCLAD

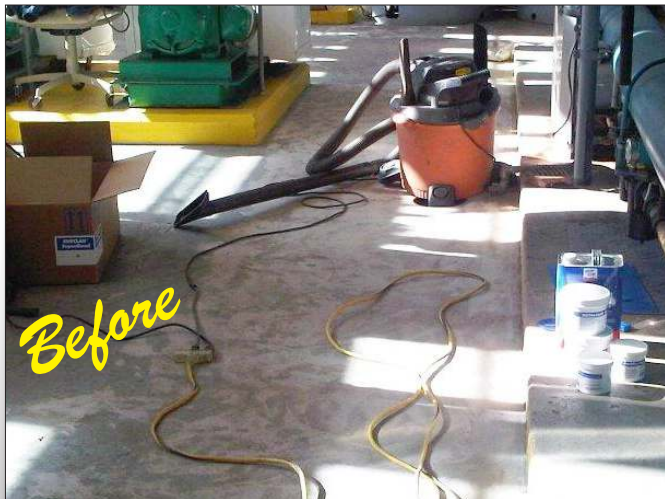
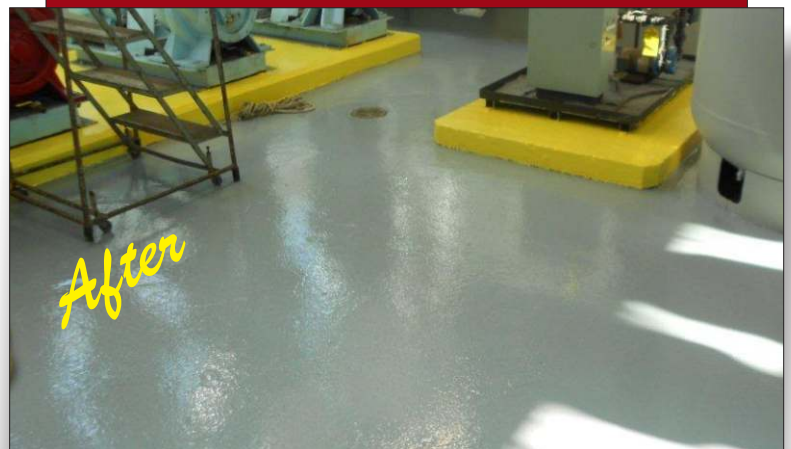
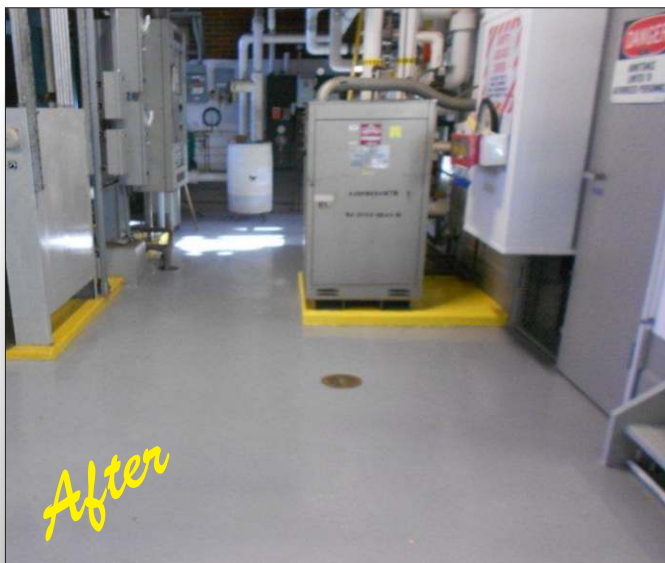
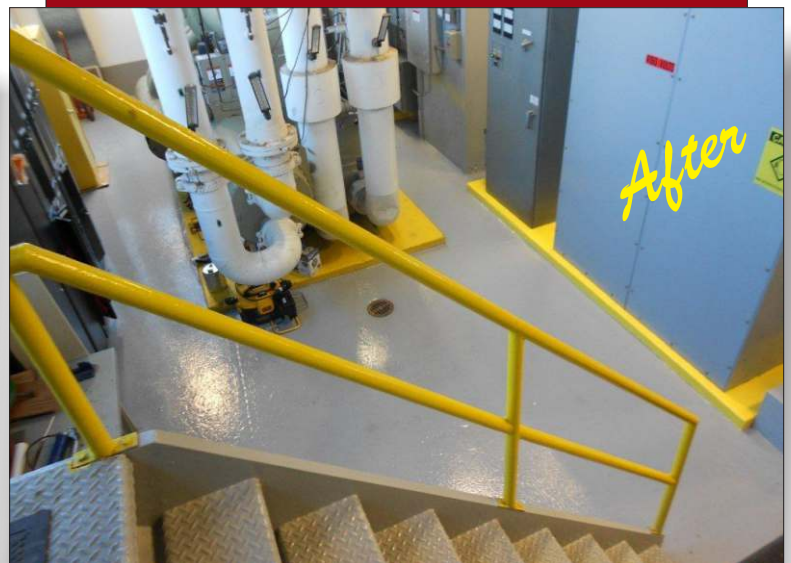
Problem: The original coating on this 2900 sq. ft. mechanical room floor was flaking and chipping. The concrete had also begun to crack and spall in several areas.

Solution: Any damaged areas were manually prepared, then repaired with ENECRETE DuraQuartz. Areas where the original coating was failing were scraped and cleaned with solvent where necessary. The entire floor was then abraded. ENECLAD SuperBond was applied to provide optimum adhesion. Finally, CHEMCLAD SC was applied with broadcast glass bead aggregate and then back-rolled to provide a slip-resistant surface.
