San Francisco Ferry Back in Service with Help from ENECON

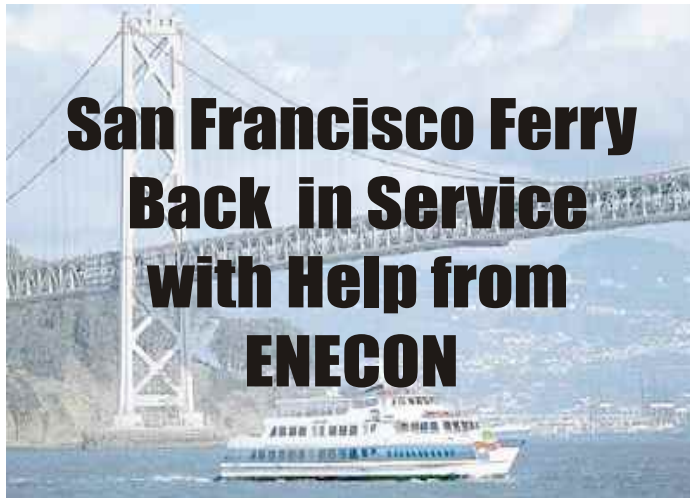
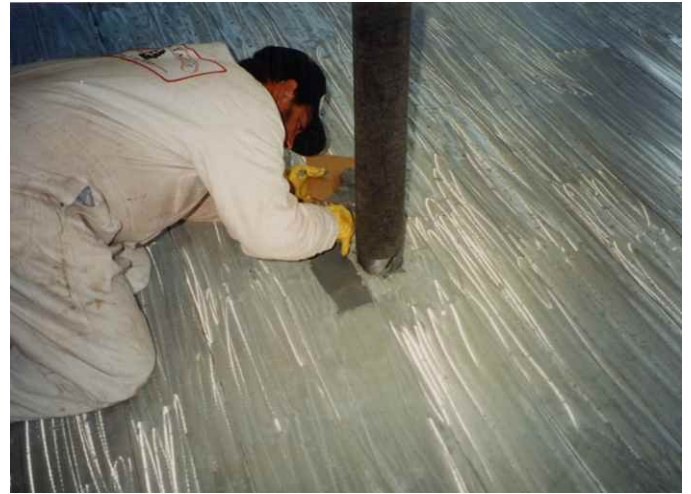
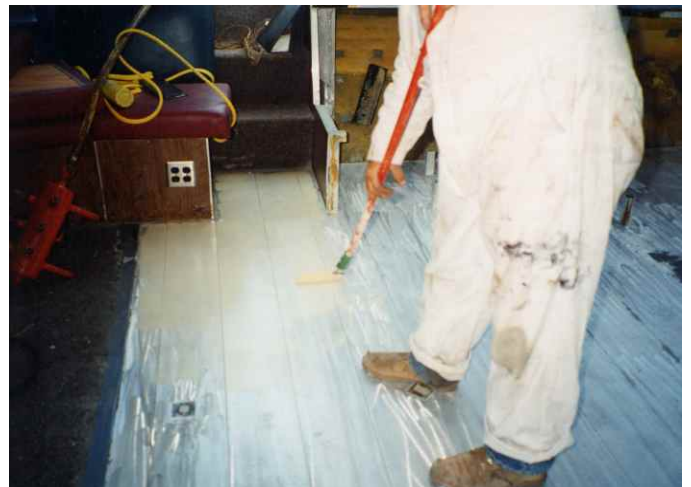
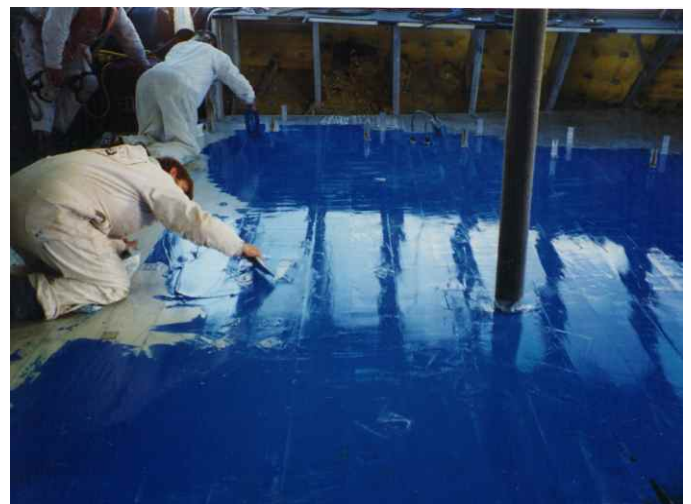
This commuter ferry operating in San Francisco Bay was experiencing an unusual problem. Its twin hull, catamaran design incorporates "tongue and groove" aluminum deck boards to span the area between the hulls. Salt water was coming up through the boards causing accelerated corrosion. In addition, the carpeting in the passenger compartment was constantly wet, resulting in complaints from the commuters and a potentially hazardous condition.

After preparing the surface, a number of badly pitted areas were identified and spot repairs were carried out using METALCLAD DurAlloy. DuraTough was then applied, followed by the application of DuraTough DL to the entire deck area.

After the DuraTough application was completed, new carpeting was installed and the vessel returned to service.
