Cooling Tower Pipes Are Salvaged With METALCLAD & ENESEAL

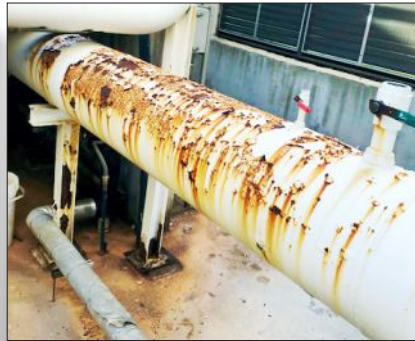
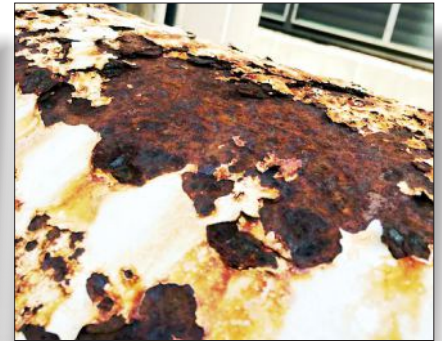
These cooling tower pipes at one of the largest hospitals in northern Louisiana were in a very corroded state. The hospital was considering replacing these pipes at an estimated cost of \$85,000, with considerable downtime. The downtime was the most troublesome issue for the hospital; they needed a solution that would allow them to keep the units operating.

Over the last few years, the hospital had continually painted the pipes, encapsulating the rusting areas unknowingly giving the rust a 'safe' place to live and thrive. After inspection, several sections of the pipes had considerable metal loss and there were also active leaks.

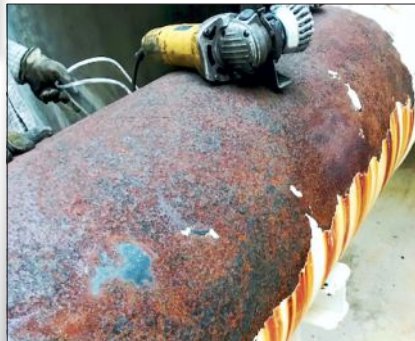
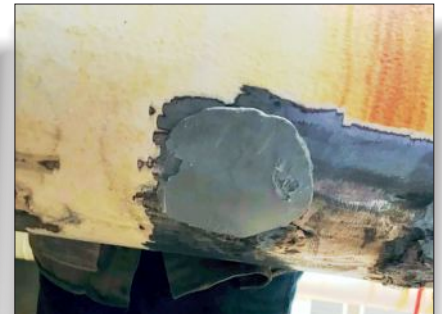
SpeedAlloy QS stops the leaks.

First, SpeedAlloy QS was used to stop all of the active leaks. After all the leaks were sealed, DurAlloy

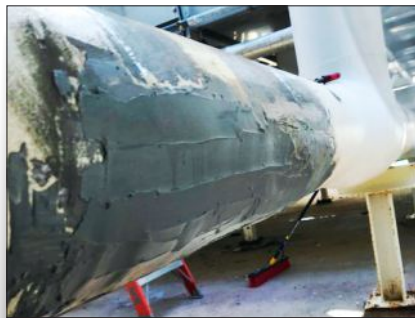
Repairs made with DurAlloy.

was then used to repair the areas with major metal loss. DuraWrap Carbon Fiber Pipe Wrap was used to reinforce the areas where the leaks were sealed and the metal loss repaired.

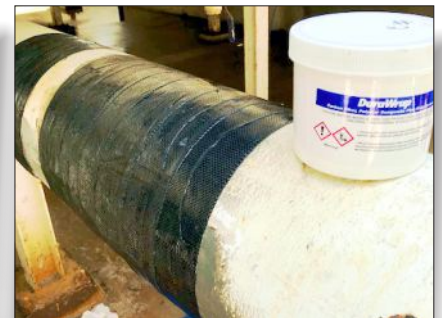
Reinforcing with DuraWrap.

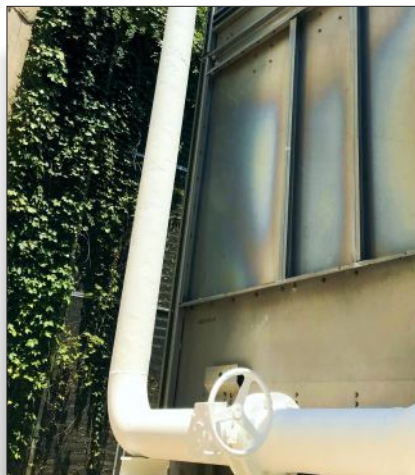
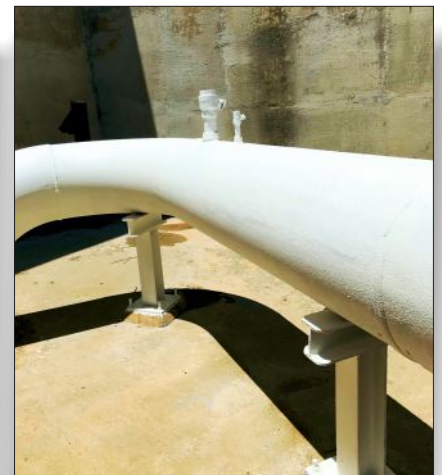
Two coats of ENESEAL CR.

Finally, two coats of ENESEAL CR were applied to all of the pipes, as well as their structural legs and concrete bases, to provide corrosion resistance. All of this work was performed with absolutely no interruption the hospitals operations.
