Water Main Pipe At Australian Steel Mill Repaired With DuraWrap

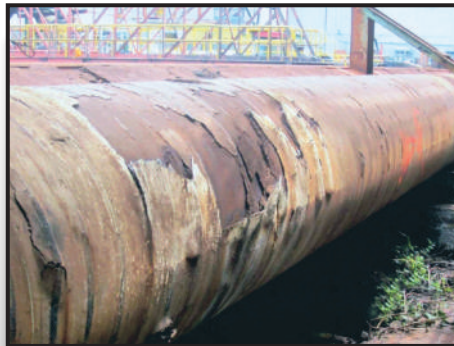
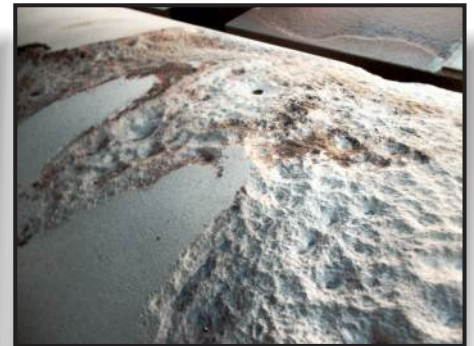
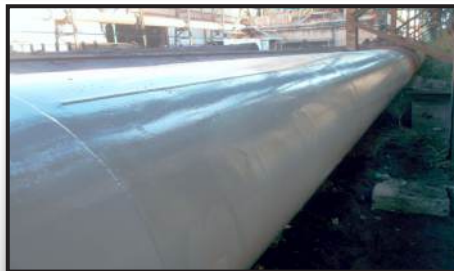
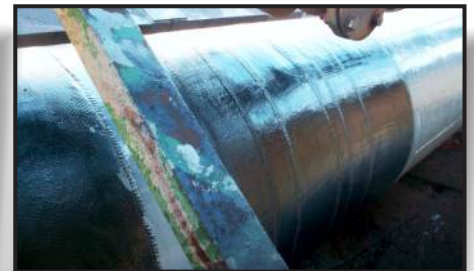
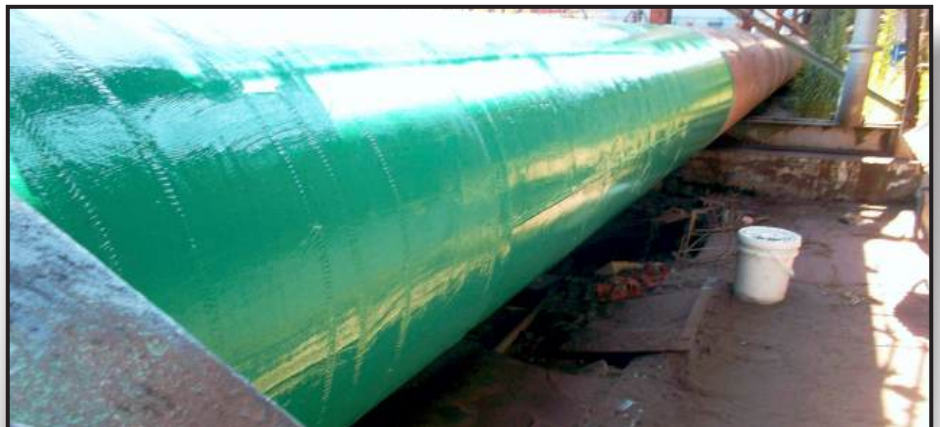
This water main pipe located at an Australian steel mill was constantly exposed to hypochlorite fall out from a nearby cooling tower as well as being in contact with sludge from the mill's process.

Even though the pipe was previously repaired with a 'tape-like' product, the pipe was showing signs of advanced corrosion in this aggressive chemical environment.

The proposed repair method required abrasive blasting to remove all traces of the old, failed protective wrap and the corrosion.

CeramAlloy CP+AC was first used to repair the heavily corroded areas of the pipe. This was followed by an application of the *DuraWrap Carbon Fiber Pipe Wrap System*, because of its extraordinary physical properties.

After full cure was achieved, the pipe was then protected with a custom colored *CHEMCLAD GP* to protect the pipe from exposure in this harsh environment.
