Pump In Operation For 30 Years At Power Plant In U.A.E. Refurbished With METALCLAD

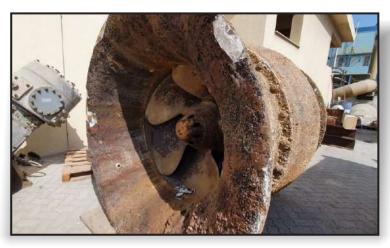
This circulating water pump had been in operation at an electric power plant in the U.A.E. for 30 years. It was opened for the first time and was found to be in poor condition.

ENECON's exclusive Distributor in the U.A.E. was contracted to refurbish the entire pump and casing. The surface was abrasive blasted to remove all the corrosion. Any cracks found on the casing were repaired with DurAlloy and DuraWrap with carbon fiber. Two coats of CeramAlloy CL+AC were then applied to protect the pump.

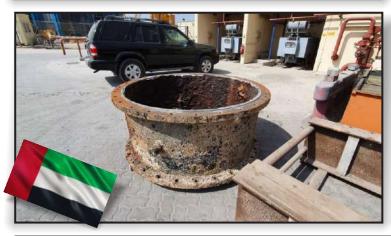
The pump is back in service and is even running at an increased efficiency.
