ECCN® NEVS

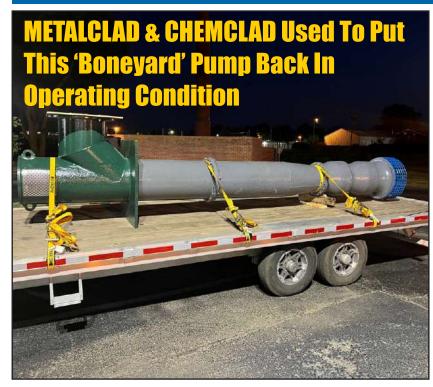
This large pump, from a southern U.S. steel mill had been left to rust away in a 'boneyard'. After an inspection it was determined that the pump could be salvaged with comprehensive repairs made with **ENECON** products, saving the steel mill operators tens-ofthousands of dollars for a new pump.

The pump was grit blasted inside and out and repairs were made with DurAlloy and by welding the severely damaged areas. After the repairs were made, the inside of the pump pieces and the end basket were protected with two coats of CeramAlloy CL+AC and the outside was protected with CHEMCLAD GP.
