DuraFill® CHEMCLAD® SC 'Heal' Crumbling, Unsafe Hospital Steps

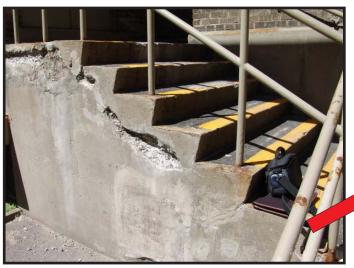
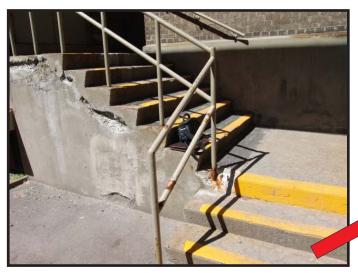
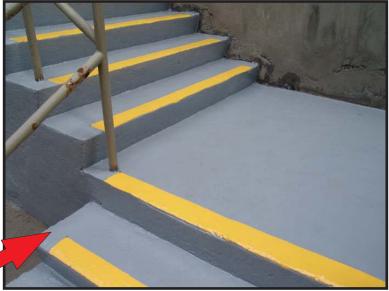
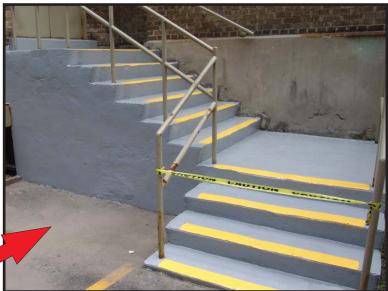
These crumbling employee entrance/exit steps at a local Montreal hospital were unsightly and a potential safety hazard. The hospital called in the local ENECON® Distributor to find a fast and cost effective solution.

After manual preparation, the steps were repaired and rebuilt in certain areas with DuraFill® mixed with locally sourced quartz sand. CHEMCLAD® SC Gray and Safety Yellow were used as top coats while a quartz sand broadcast was back-rolled in to provide slip resistance.
