ELECON® NEVIS

A major corrugated carton manufacturer in Colombia was faced with the issue of having to resurface their production rollers every 30 days. If roller diameters get too low, they need to be replaced entirely.

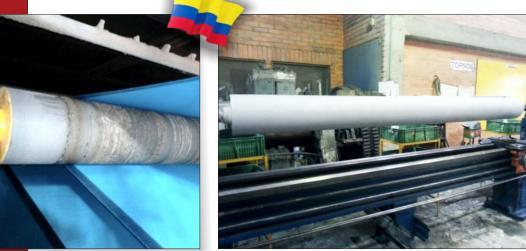
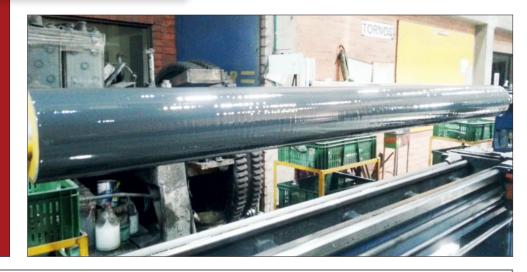
ENECON Colombia was asked to help find a solution to this problem by repairing two 'test' rollers. The rollers operate at a potential maximum temperature of 302°F/150°C.

The rollers were prepared by grit blasting. Two coats of CeramAlloy HTL were then applied to completely resurface the rollers.

Each roller requires 4kg of CeramAlloy HTL. Previous repair methods of metalizing would cost \$3,000USD per roller. ENECON's CeramAlloy HTL cost half the price. Additionally, the ENECON solution cut maintenance time of these rollers significantly.
