## METALCLAD, ENECLAD, FLEXICLAD & CHEMCLAD Used To Repair & Protect Rooftop Air Handler Unit

This rooftop air handler unit is located on the roof of 19 story building on the coast of western Florida. After years in service and exposure to an extreme salt air environment the unit was suffering from significant corrosion damage.

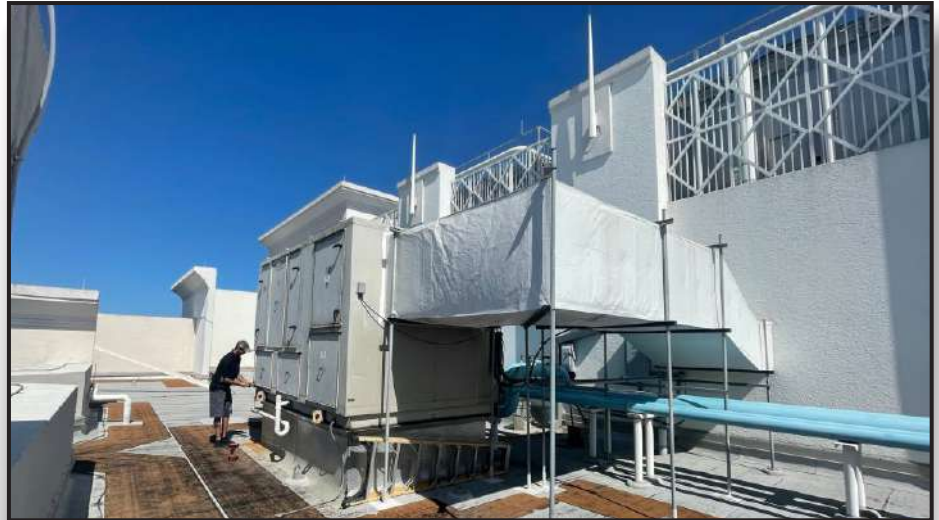
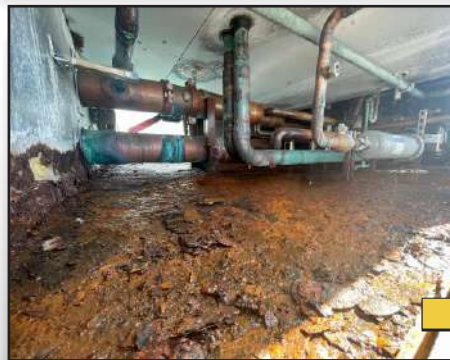
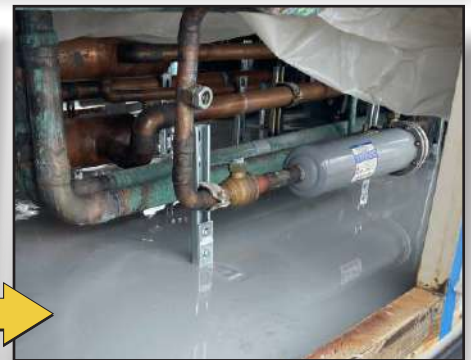
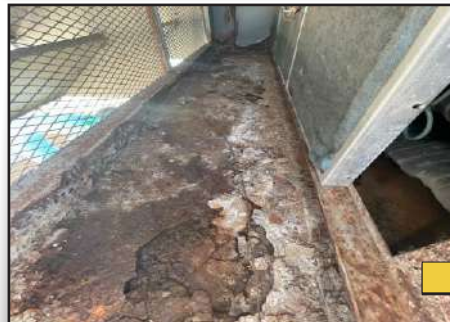
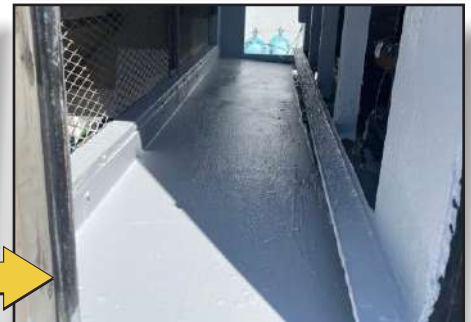
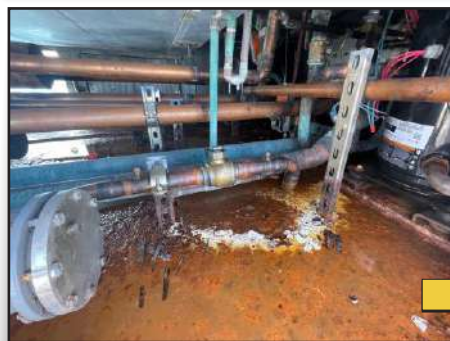
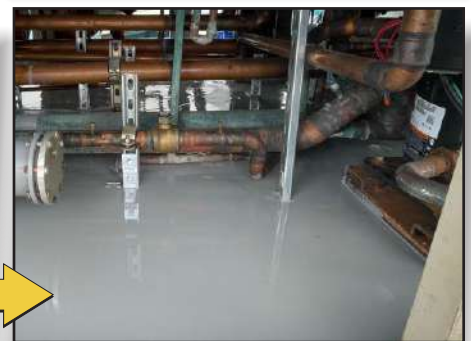
The air handler's compressor section, coil drain cabinet pan, and air inlet chamber were very corroded and leaking. The building's management was considering replacing the unit.

The areas to be repaired were mechanically prepared using a hand grinder and then cleaned sufficiently.

A combination of *DurAlloy* and sheet metal were used to make necessary repairs to the air inlet chamber of the unit. *FLEXICLAD ER* was used on the sheet metal seam joints and *ENECLAD SPS* was used to pitch the cabinet pan towards the drain to ensure proper drainage.

Finally, *CHEMCLAD GP* was used to protect all of the internal surfaces from future corrosion. The management was very happy with the results as well as the considerable cost savings.
