Pennsylvania Hospital Uses CHEMCLAD GP To Seal Bathroom Floor & Stop Leaks To Floor Below

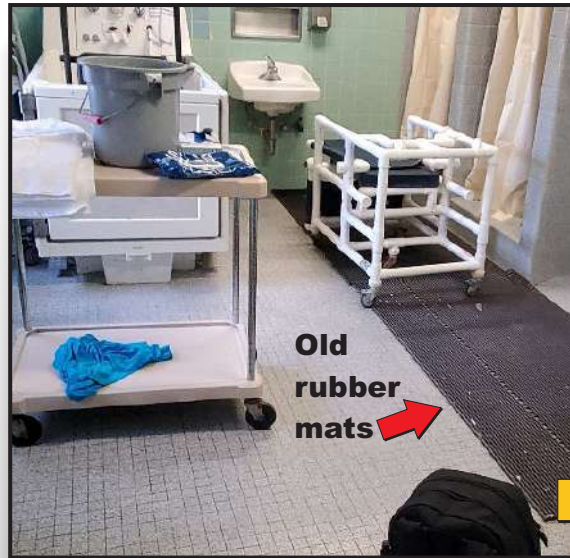
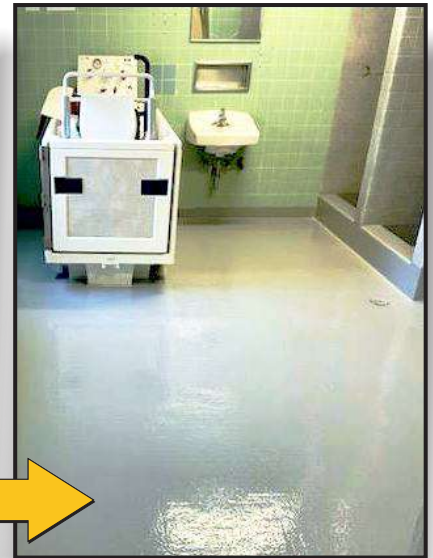
Old rubber mats

A hospital in eastern Pennsylvania was having a problem in a first floor bathroom that was leaking down into the basement below.

Two coats of ENECON's general purpose polymer system, **CHEMCLAD GP**, were applied with an aggregate broadcast in between coats to provide slip-resistance properties to replace the old rubber mats.
