This damaged concrete effluent tank is located at an explosives company in Australia. The effluent water inside of this tank contains cyanide and ammonium nitrate.

REPAIR - DON'T REPLACE

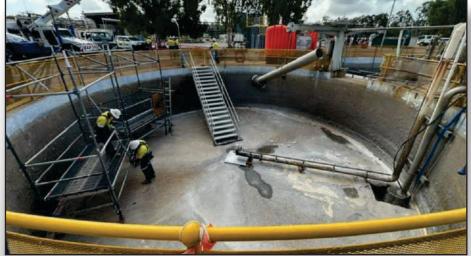
After years in service the concrete floor and wall were showing signs of deterioration After the from chemical attack. **ENECON's** Exclusive **Distributor in** Australia was contacted and asked to provide a solution to this problem.
