Popular Cocktail Bar In Cyprus Uses ENECRETE DuraFill To Repair Crumbling Floor

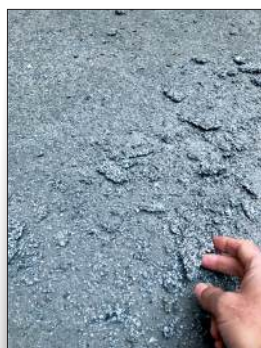
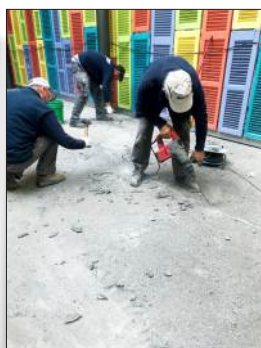
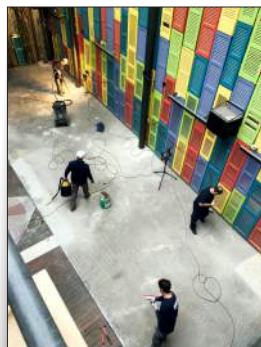
All the loose flooring material is removed

The flooring material at this cocktail bar in Cyprus was deteriorating and coming loose. This was both unsightly and a potential tripping hazard. The bar's owners needed to find a quick and effective solution to solve this problem.

The existing, failing flooring material was removed and the

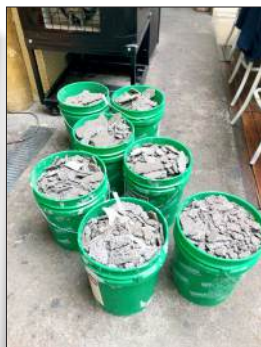
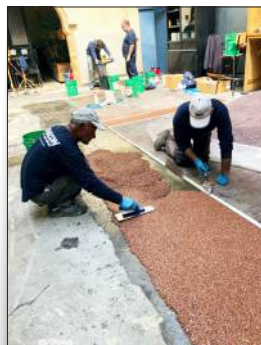
The substrate is prepared

concrete substrate was cleaned and left to dry. **ENECRETE DuraFill** was applied by brush and roller to the concrete as a primer. The owners had chosen a decorative stone that was mixed with the *DuraFill* and applied to the floor. Once this step of the application was completed, a layer of *DuraFill* resins was rolled onto the floor to seal it and provide maximum protection.

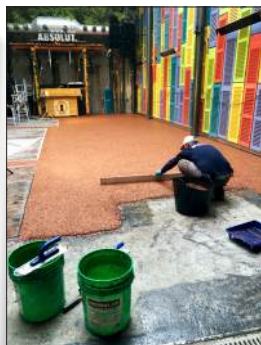
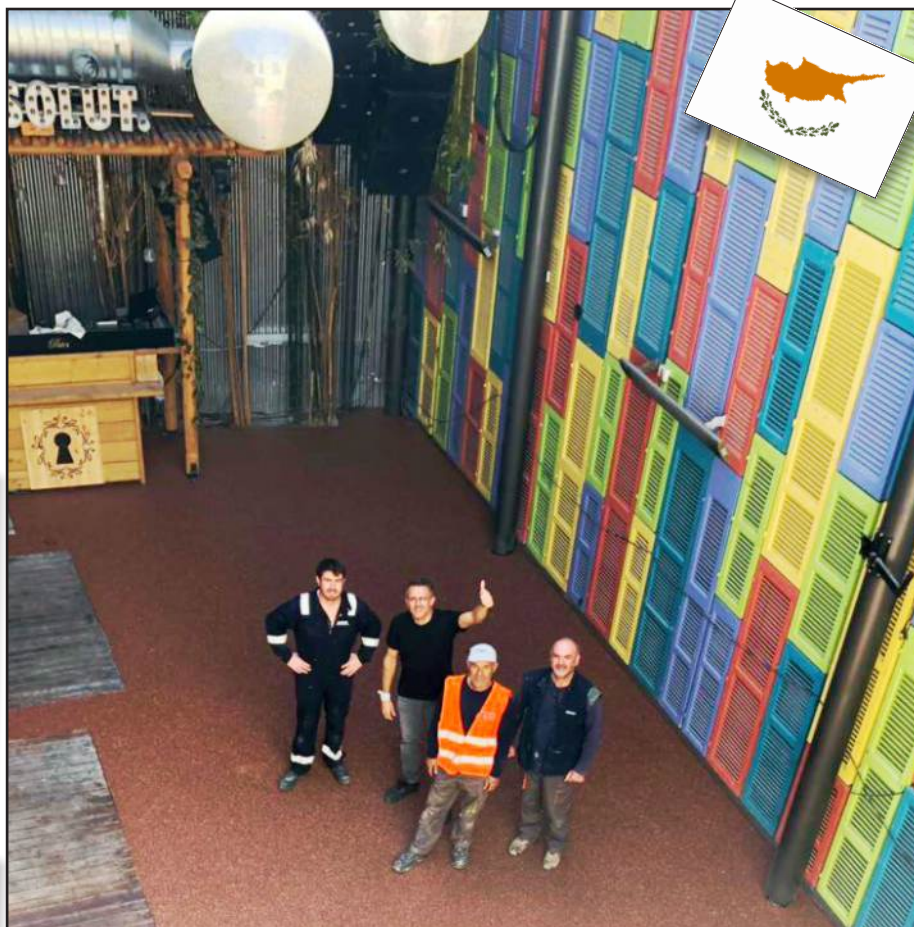
DuraFill and decorative stone is applied

Within 48 hours ENECON Cyprus was able to deliver the bar's owners a completely new floor that not only looked great but also had much better resistance to foot traffic and spilled drinks than the previous material.
