Staircases At Colorado High School Are Repaired & Protected With METALCLAD, CHEMCLAD & ENESEAL

Client: High School Campus

Location: Colorado, U.S.

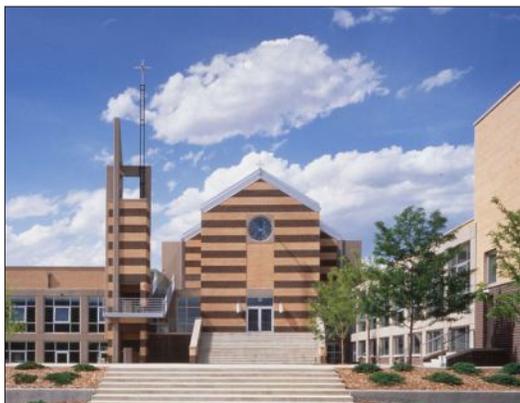
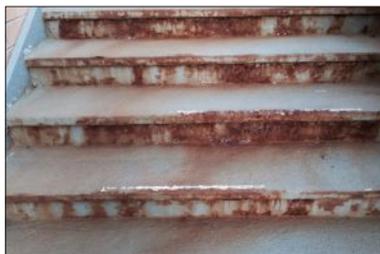
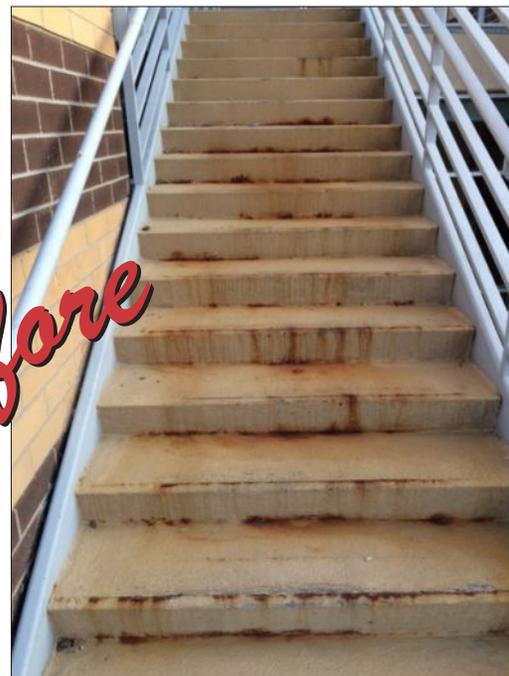
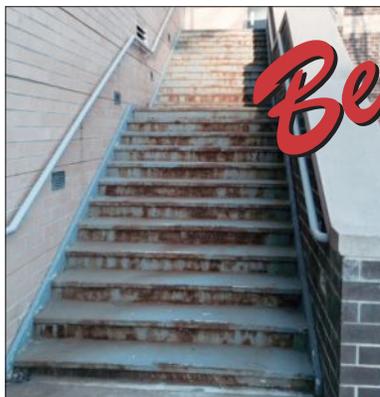
Before

Problem: High traffic staircases were suffering from corroded steel tread nosings and damaged concrete treads. This caused both unsafe conditions for students, faculty and visitors as well as being very unsightly.

Solution: The stairs were manually prepared by abrasive blasting the steel nosings and concrete treads to remove any corrosion and old, failed coating systems. The nosings were given a first coat of CHEMCLAD SC and the concrete was primed with CHEMCLAD P4C. DurAlloy was then used to fill in any pitted areas. A top coat of CHEMCLAD SC Tan was applied and white aluminum oxide was back-rolled to provide slip-resistance. Finally, the staircase steel frames were cleaned and ENESEAL CR was applied to provide corrosion resistance.
