ENECON® NEVS

Water Slide Stairs Protected With CHEMCLAD SC

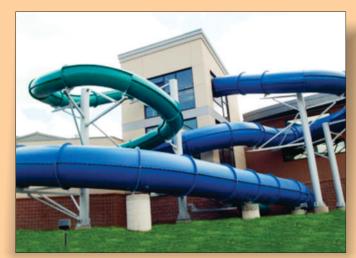
This indoor water slide staircase located at a local town pool in Colorado was in need of repair due to corrosion and degradation after only 9 years of use and exposure to chlorinated water. The multiple level concrete and steel structure has 4 separate landings.

The railings, stringers, underside steel decking, risers as well as the concrete treads and landings were all grit blasted and / or manually prepared to remove previous failed coatings. Three coats of CHEMCLAD SC were then applied to all of the steel.

The concrete areas were first primed with CHEMCLAD P4C followed by 2 coats of CHEMCLAD SC. An aggregate was back-rolled into this application to provide slip resistant properties.
