## ELECON® NEVIS

**REPAIR - DON'T REPLACE**

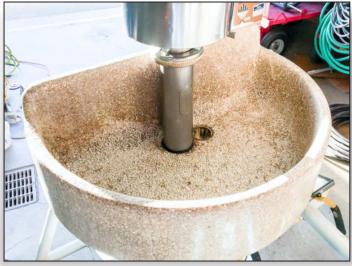
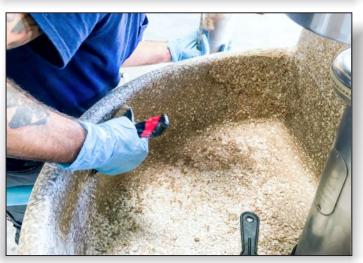
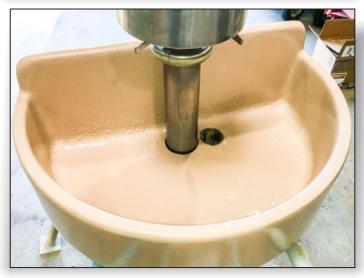
After 40 years in use the inside of the sink was worn down to the aggregate. The maintenance engineers at the facility were quoted over \$5,000 for a replacement sink. That's when ENECON NorCal was called in to help prescribe a more cost effective solution.

After wire wheel surface preparation as well as the use of heat lamps for a few days to dry out the substrate, the repair consisted of DuraFill to wet out and prime the entire surface. Then DuraFill with fine quartz sand was used to fill in the voids. A third application of DuraFill was completed to level any uneven areas in the sink. Finally, 3 coats of CHEMCLAD SC in tan were applied.

The sink looks like new and the customer is thrilled with the results. More sink 'rescue' applications will be performed at this and other facilities in the near future.
