40 Units of ENECRETE[®] DuraFill[®] Used to Repair Cracked Concrete Floors in 8 Costa Rican Warehouses

Client: An 8 unit warehousing complex in Costa Rica.

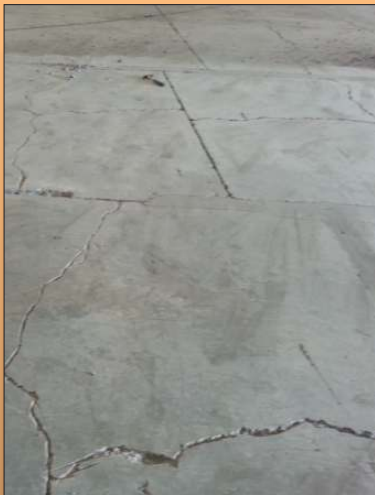
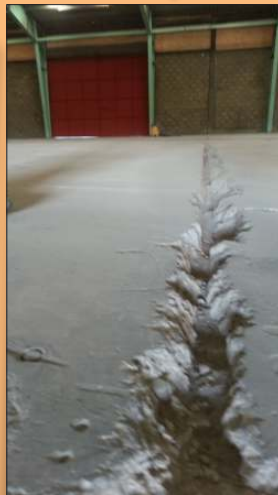
Problem: 20 year old warehouse concrete floors were severely cracked due to several factors, including excess weight being stored.

Solution: It was decided that ENECRETE[®] DuraFill[®], mixed with locally sourced quartz sand, was the most cost effective course of action to solve this problem. All of the cracks were first opened up mechanically with a grinding wheel. The loose material was vacuumed up. The DuraFill[®] / sand mixture was then poured into the cracks. Before the DuraFill[®] was fully cured it was sanded down seamlessly to the floor's height.
