## Western US Candy Company Stops Entry Railing Corrosion with ENECRETE & ENESEAL

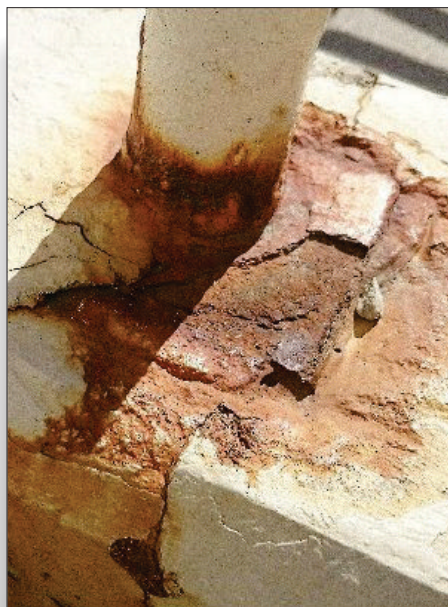
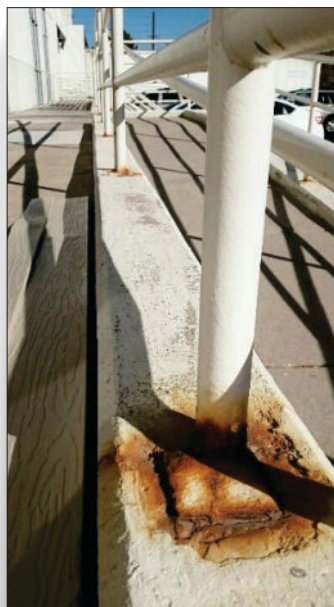
A candy manufacturer in the western United States contacted ENECON in the hope of solving a severe corrosion issue that was not only unsightly but beginning to impact the steel railing's structural integrity.

Besides simply removing the rust and coating the railing, it was observed that an original design flaw caused water and ice melt products to pond at the railing base flanges. This was the cause of the corrosion.

The ENECON solution was to remove the loose rust and rebuild

the areas around the base flanges with **ENECRETE DuraQuartz** to solve the ponding issues.

With its extraordinary bond strength to both existing concrete and steel, as well as zero shrinkage during curing, **DuraQuartz** was the ideal solution.
