Corroded Steel Cooling Tower Support Beams Are Protected With ENESEAL CR

A downtown Seattle office building has these large cooling towers on top of galvanized support beams. The beams were corroding due to the environmental conditions in which cooling towers historically operate.

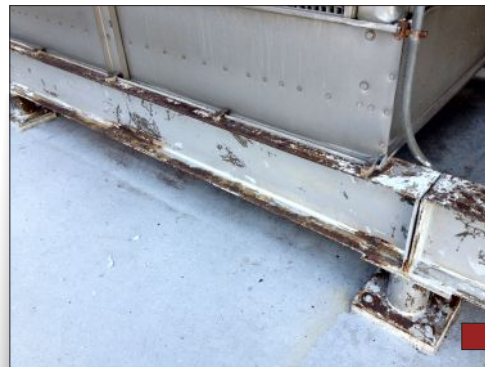
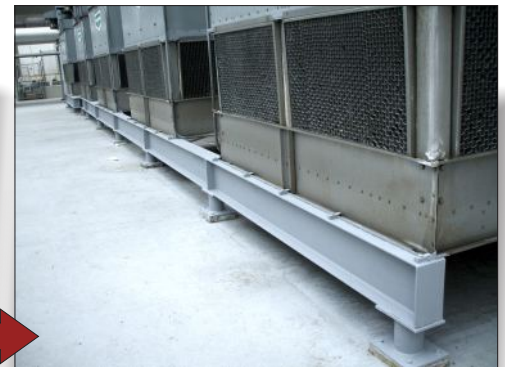
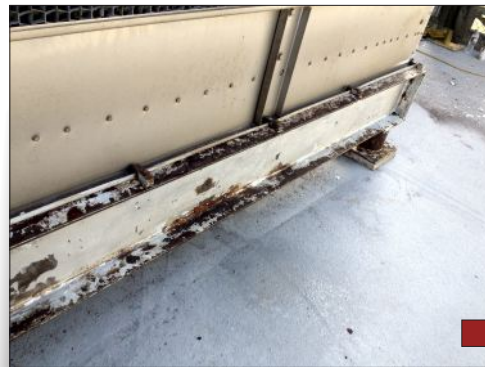
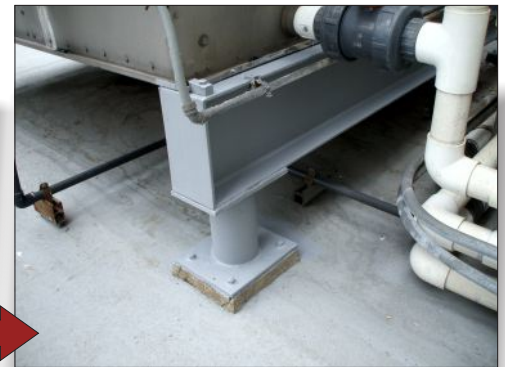
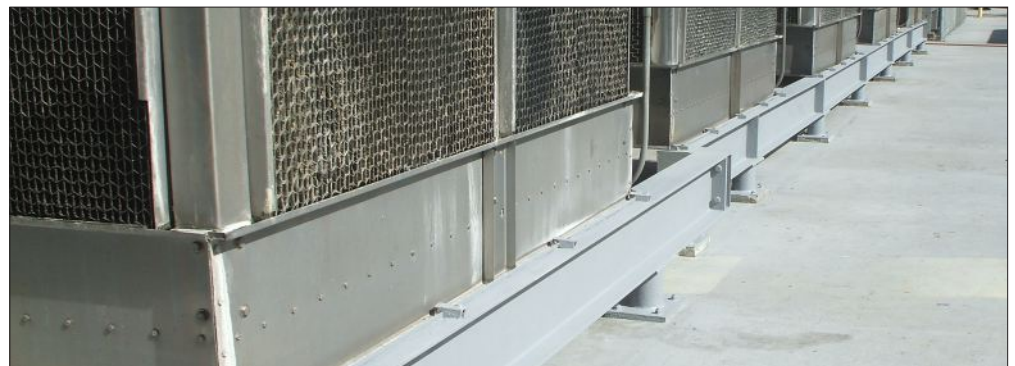
The support beams pictured had been painted with a "high-quality" marine paint just one year prior to this project taking place. The previously applied paint was already peeling off due to the prior coatings' inability to bond to the galvanized surface of the support beams.

The beams were first prepared by pressure washing and then hand grinding was used to remove any remaining paint and rust. Once the surface was properly prepared, two coats of ENESEAL CR, tinted to a custom gray color, were applied to provide long term corrosion resistance.
