Client: Sewage plant

Location: Southern Florida

Southern Florida Sewage Plant Uses ENESEAL to Stop Rust and Reduce Heat on Generator Cabinets

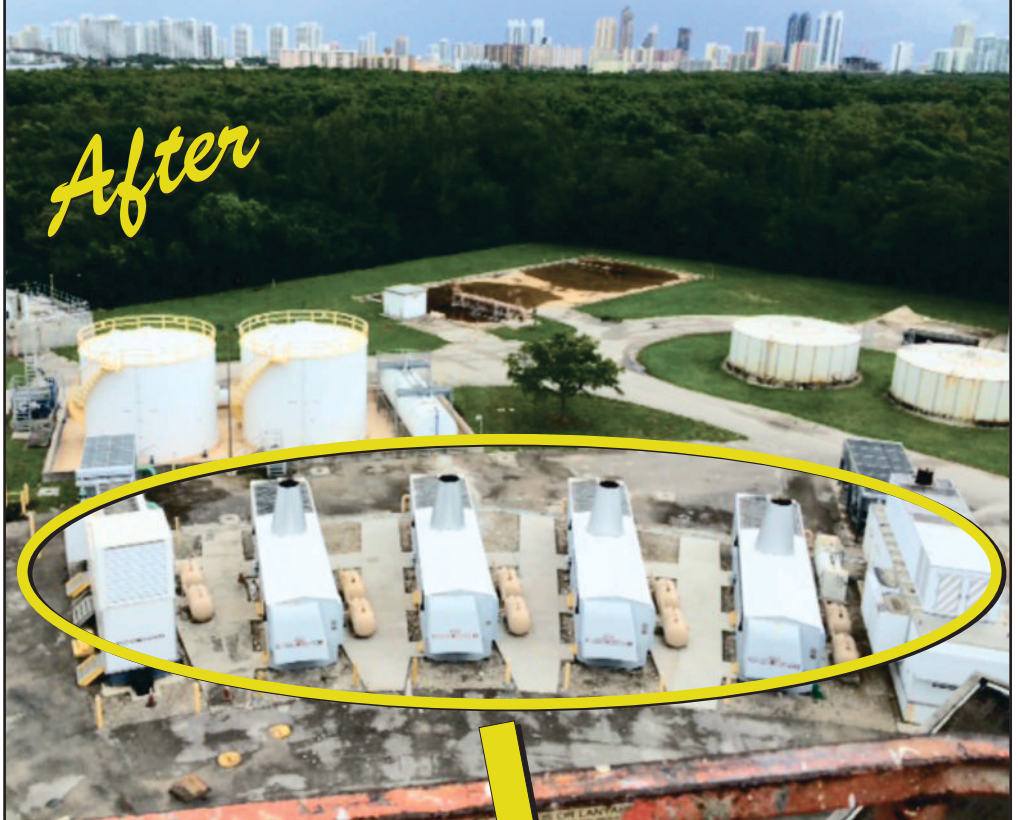
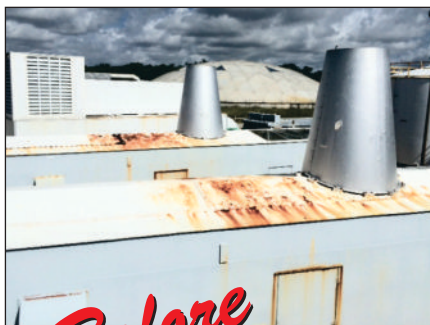
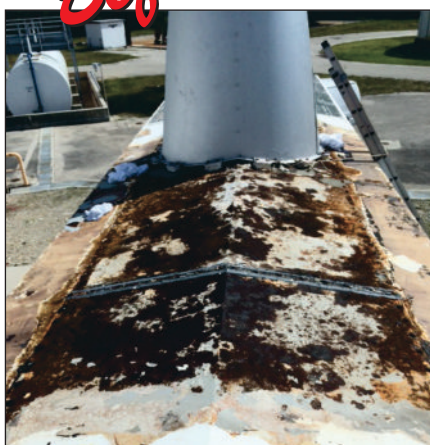
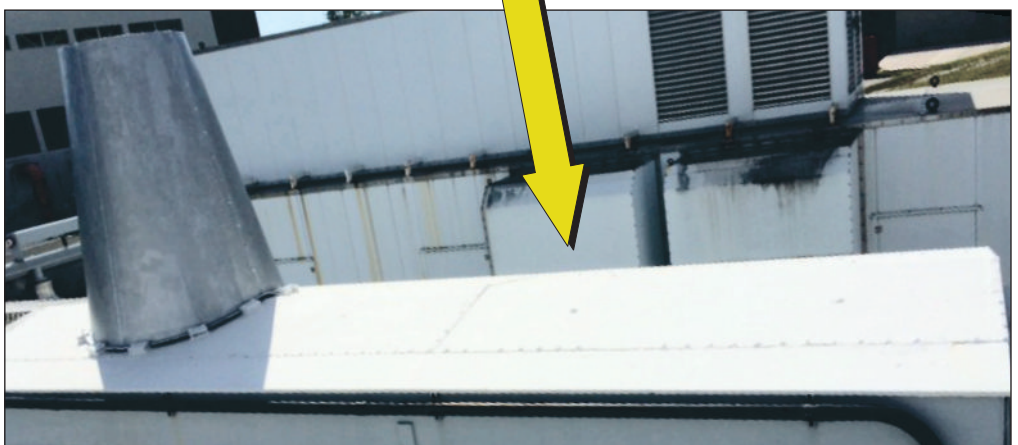
Problem: Extreme rust, corrosion & peeling paint on generator cabinets as well as elevated internal cabinet temperatures from the sun.

Solution: After preparing the surface with a wire wheel, 3 coats of ENESEAL CR were applied to provide corrosion resistance followed by 2 coats of ENESEAL HR to give heat refractive properties to the cabinet roofs.
