*DuraTough-ing Out*  
**CAVITATION**  
**ATTACK**

A hydroelectric plant in British Columbia, Canada, has found the use of our ENECON FLEXICLAD DuraTough to be the best method of repairing and protecting these Francis Turbine Runners from severe cavitation attack.

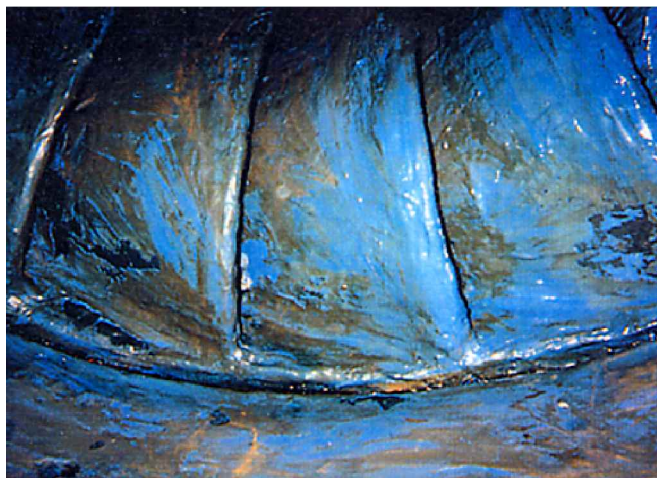
runner was inspected to determine the in-service performance capabilities of the DuraTough system.

The repair, and the DuraTough DL, had performed beyond expectations.

After 12 months of continuous service, the
