Front End Loader Tire Sidewall Repaired with FLEXICLAD ER

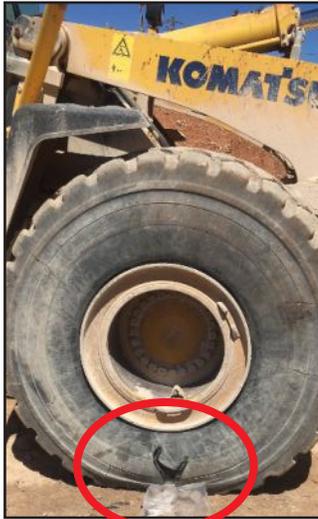
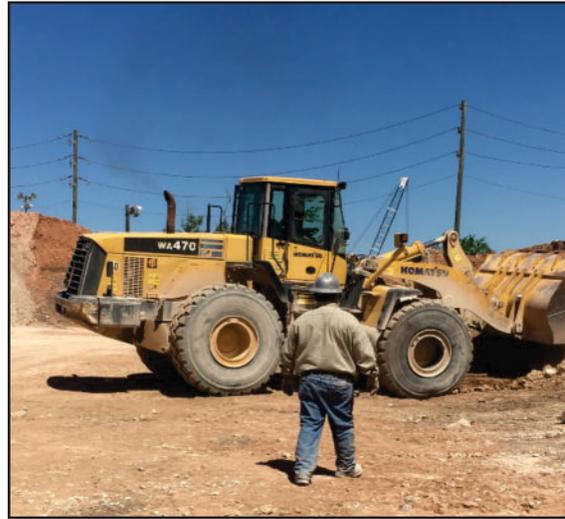
This front end loader is used to scoop up barite (barium ore) which is ground and made into oil drilling mud. The tires are exposed to an extremely harsh environment that often causes damage to their sidewalls.

As shown here, the tire damage is substantial. The cost to replace this tire is \$8,000 (\$5,400 used), plus labor. Downtime for this loader can cost as much as \$100,000.00 per day. The barium crushing plant's engineers decided to give the ENECON FLEXICLAD ER a try.
