The Cost Effective Solution

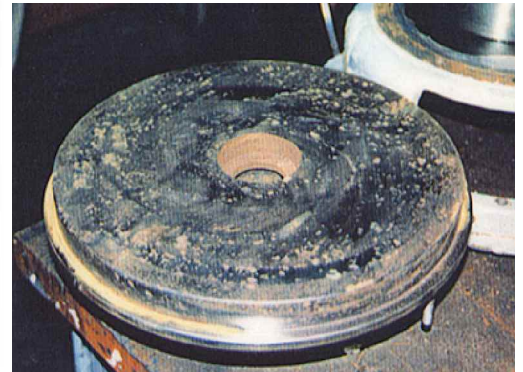
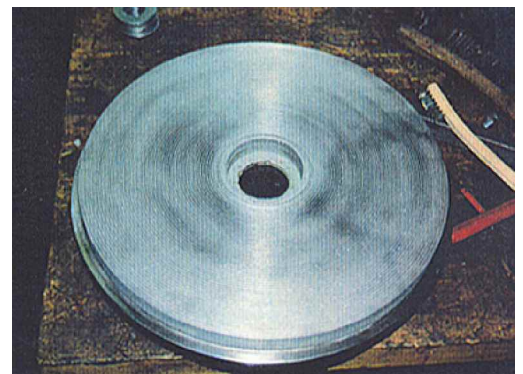
The maintenance supervisor and his crew had a damaged pump from their service water system disassembled and on the workbench. The back plate of the pump had severe cavitation damage; and, to make matters worse, the pump shaft was also badly scored in the bearing area.

The damaged back plate was first machined down and “grooved” and then rebuilt with DurAlloy to the desired dimensions and contours. The plate was then coated with the DuraTough system to extend its service life.
