METALCLAD CeramAlloy CP+AC Repairs Pitting and Corrosion on Hydroelectric Dam Tainter Gates

Client: U.S. Army Corps of Engineers (USACE)

Location: Dam and hydroelectric plant in the Eastern U.S.

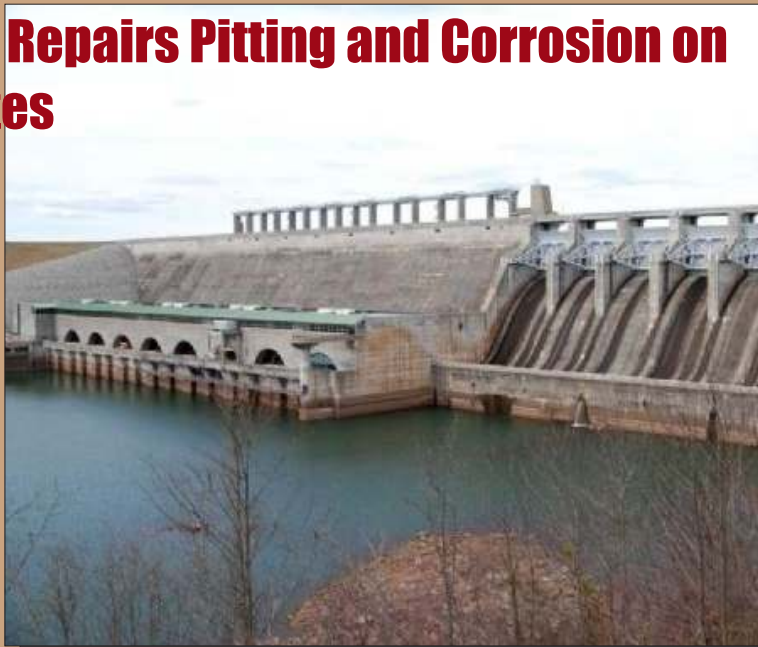
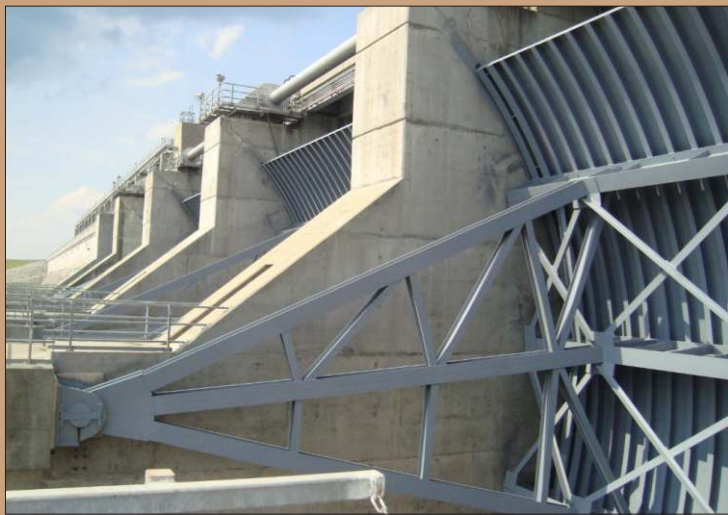
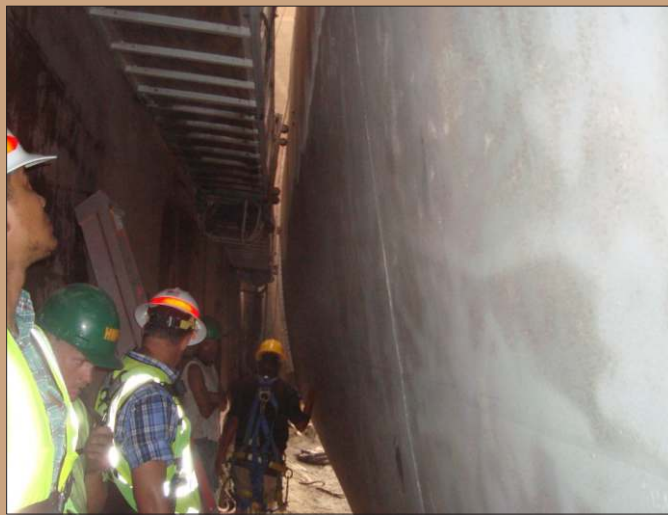
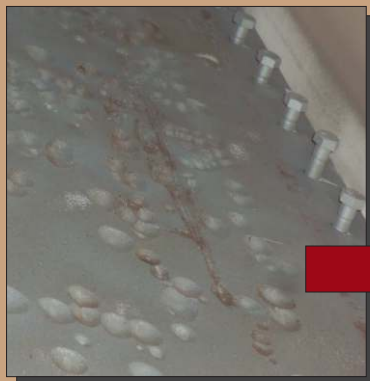
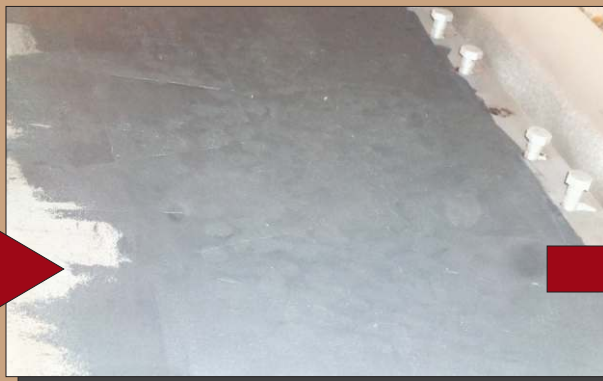
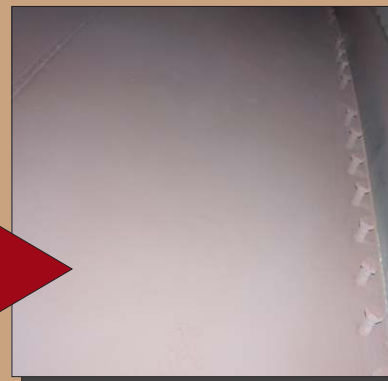
Problem: Severe corrosion and pitting on the dam's 10 Tainter gates.

Solution: After grit blasting, traditional repair methods consisted of 'puddle welding' the pitted areas. **CeramAlloy CP+AC** was used instead of welding to repair the corrosion damage. A standard multi-coat vinyl marine paint system was then applied to by the on-site contractor to comply with the USACE's specifications.
