Power Plant in Thailand Uses CeramAlloy and CHEMCLAD to Repair and Protect Cooling Water Pipeline

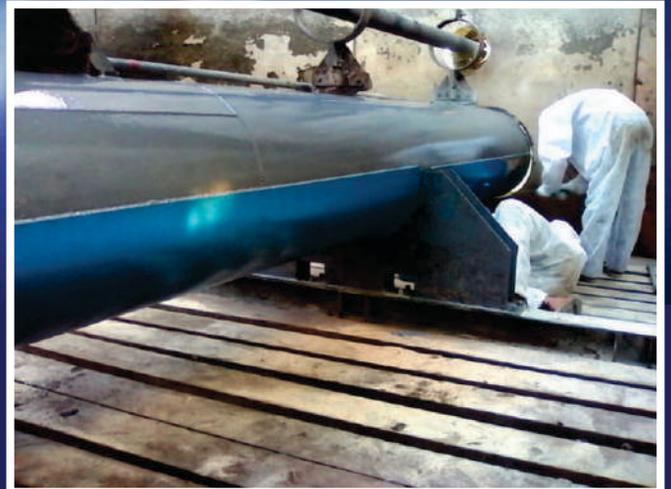
This cooling water pipeline at a power plant in northern Thailand is subject to severe erosion and corrosion due to water forced out by the fans located on top of the pipes as seen in the bottom left photograph.

The bottom half of the pipe (only 2 mm / .08 inches thick in some areas) was repaired using welded plates which were bonded to the pipe with CeramAlloy CP+AC followed by two layers of CeramAlloy CL+AC.

The top of the pipe was coated with CHEMCLAD GP as a cost saving measure.
