Chilean Hospital Pumps Brought 'Back to Life' with CeramAlloy[®] and CHEMCLAD[®]

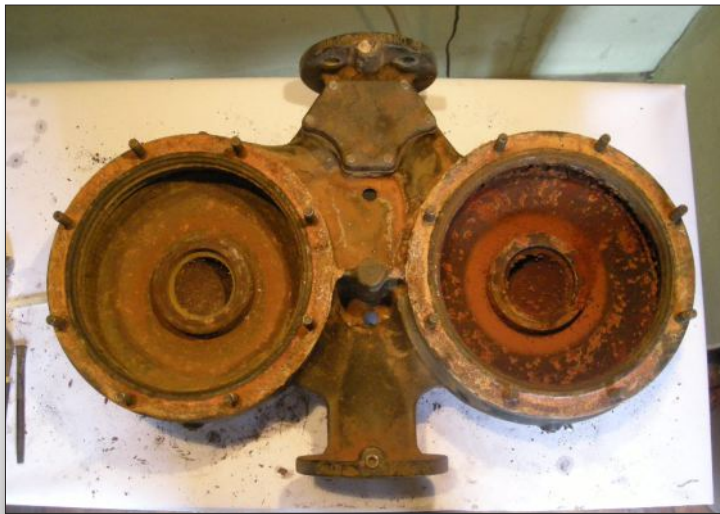
This hard water pump at a hospital in Chile was only averaging a few months in service before maintenance would have to be performed to repair deep erosion / corrosion damage.

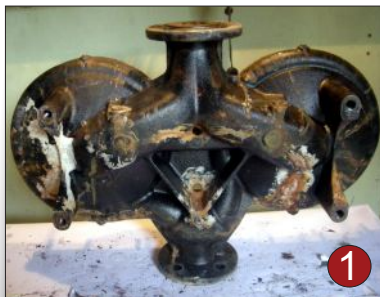
1. The pump casing before being refurbished.

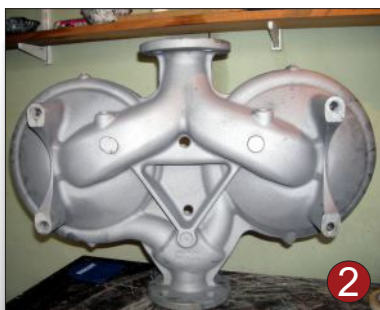
2. The pump casing after grit blasting.

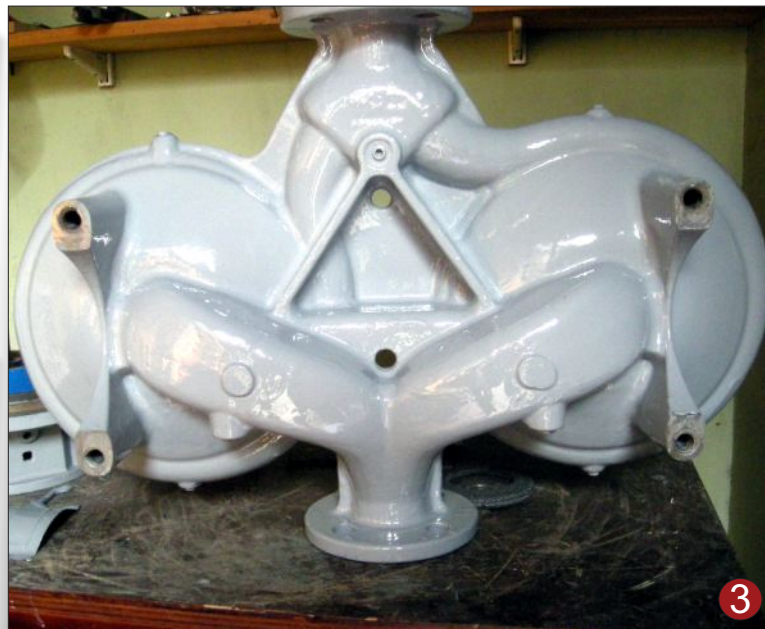
3. The pump casing was coated with CHEMCLAD SC which protects from future erosion / corrosion.
