CeramAlloy Used To Repair & Protect 35 Year Old Chiller

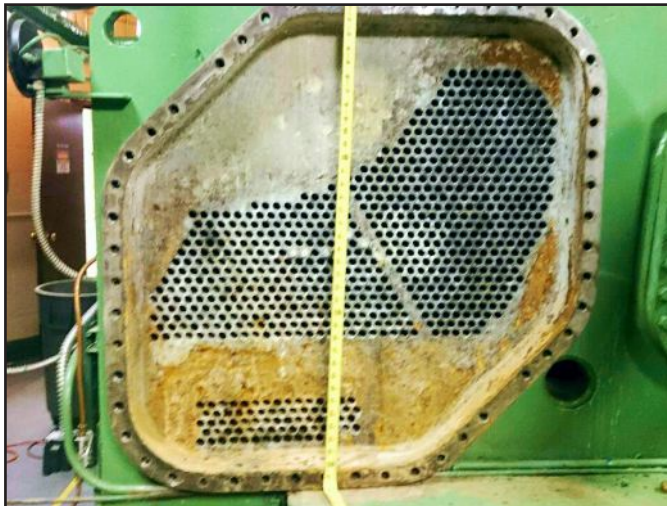
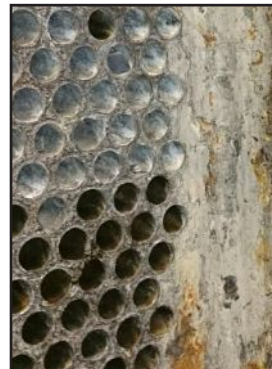
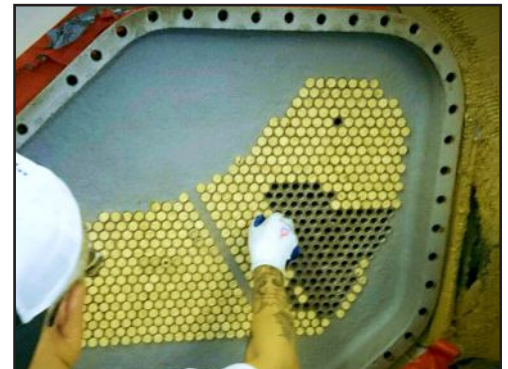
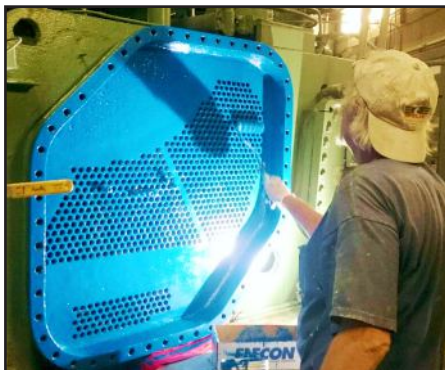
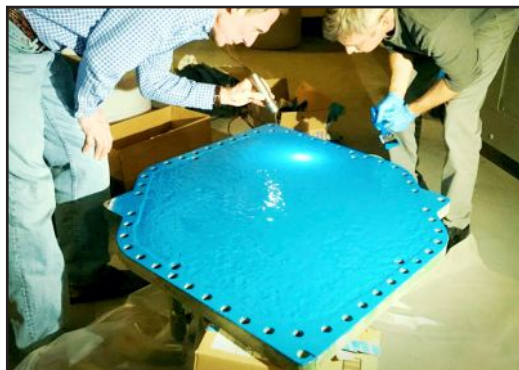
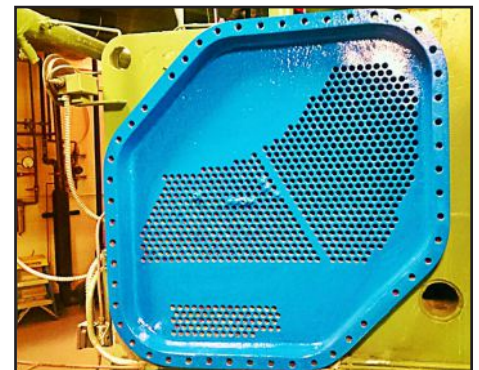
A Denver office building was dealing with a large, 35 year old chiller that had begun to leak around the gasket. Upon inspection it was discovered that there were several causes of the leak.

Years of use of a daisy style gasket had exposed sections of the flange face to erosion and corrosion. The inside face of the box near the flange was eroded as well as a groove worn into the end cap.

the damaged areas. Two coats of CeramAlloy CL+AC were then applied to protect these components from future erosion / corrosion damage.

ENECON was able to bring this huge 18 foot long, 35 year old unit back into service and deliver a solution designed to give them many years of additional service.

After grit blasting, METALCLAD CeramAlloy CP+AC was used to rebuild
