## Outdoor Fountain At Pennsylvania Landmark Building Is Repaired With CeramAlloy CL+AC

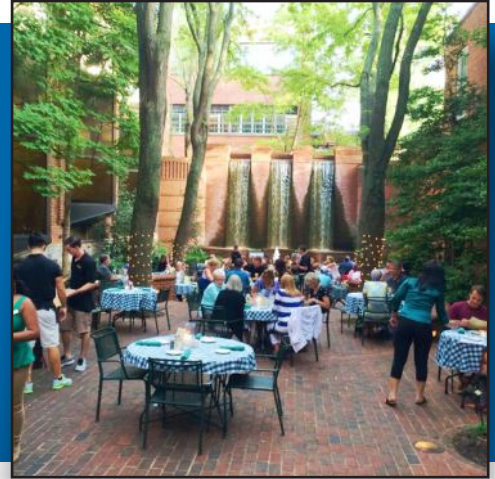
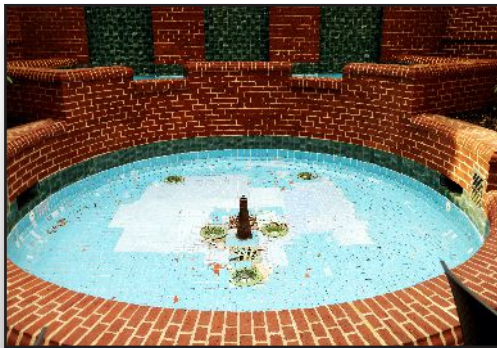
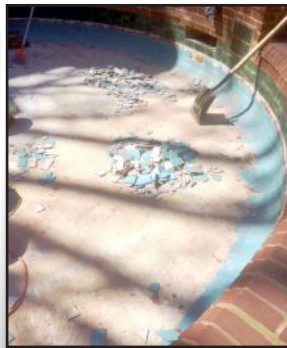
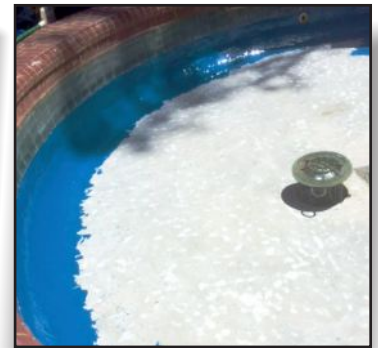
This fountain, located in the outdoor dining area of a restaurant, was in need of serious repair. The fountain's tiles were coming loose and very difficult to color match and replace. The replaced tiles wouldn't hold in place very long either.

The fountain was drained of its water and all of the tiles were removed. The concrete surface was manually prepared with a grinding wheel. Two

coats of CeramAlloy CL+AC were then applied to provide fluid flow erosion and corrosion resistance.
