These steel digester tanks are used in Northern California to break down yard waste and use it in the production of biofuel.

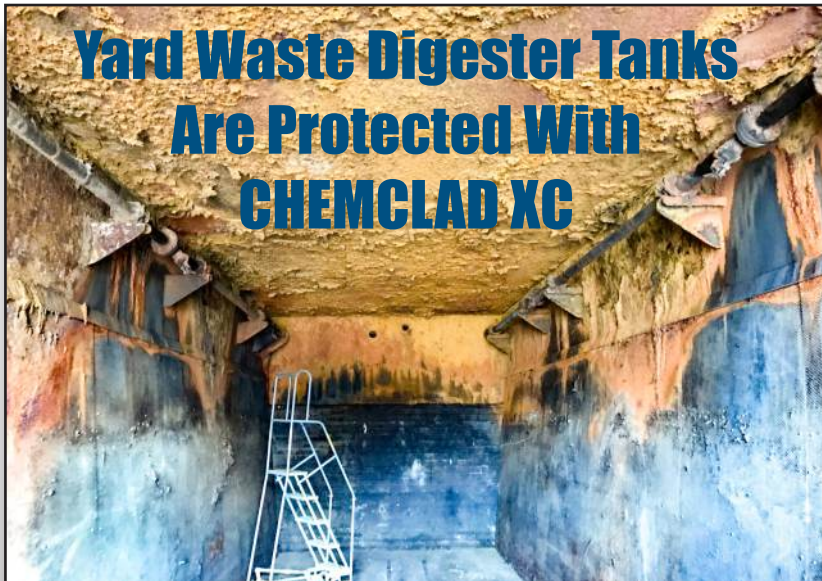
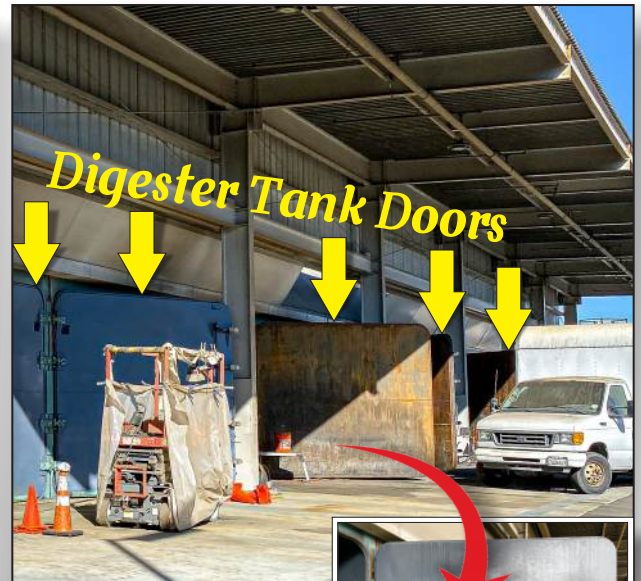
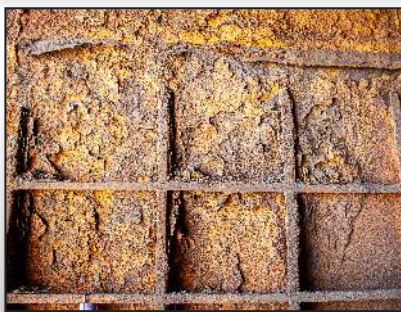
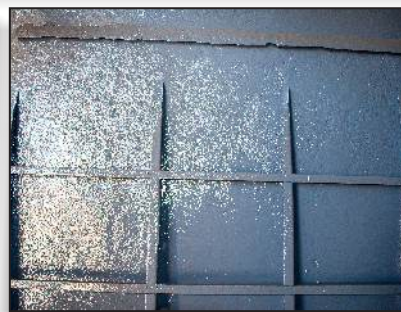
After years of use, the interiors of these tanks were suffering from advanced corrosion. The tanks were emptied, and the screens that line the walls were removed. All of the steel surfaces, including the doors, were then abrasive blasted.

Since these tanks are hermetically sealed during the waste breakdown process, it was crucial that the walls have no holes

in order to be air-tight. That meant that all damaged areas had to be repaired and sealed with *CeramAlloy CP+AC*.

The final step of this project was the application of two coats of *CHEMCLAD XC* to provide the best chemical protection possible in this corrosive environment.

In all, 8 digester tanks were repaired and protected at this facility.
