## Canadian Fish Hatchery Uses ENECRETE, ENECLAD & CHEMCLAD To Repair & Protect Trout Pool 10 Years Ago & It Is Still Perfect

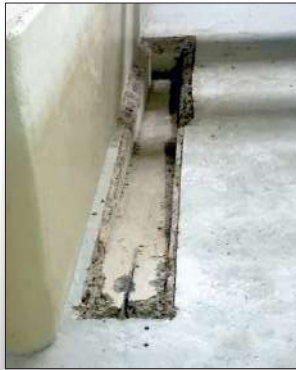
Filter removed

The old filter was cut out of the concrete and a new filter, provided by the hatchery, was set into place using DuraQuartz RR to create a “seat” to ensure a snug fit for the filter. DuraFill with locally sourced aggregate was then used to fill-in the remaining sections of cut-out concrete around the filter.

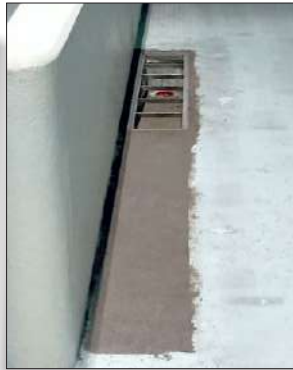
New filter installed

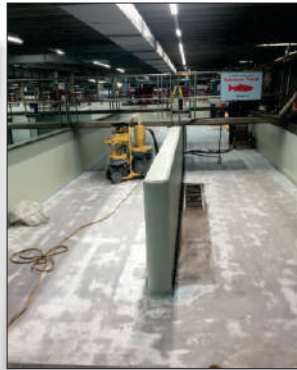
Pool floor prepared

The entire pool floor was then prepared using a floor grinder. ENECLAD CFS was used to prime the floor then two coats of CHEMCLAD SC were then applied.

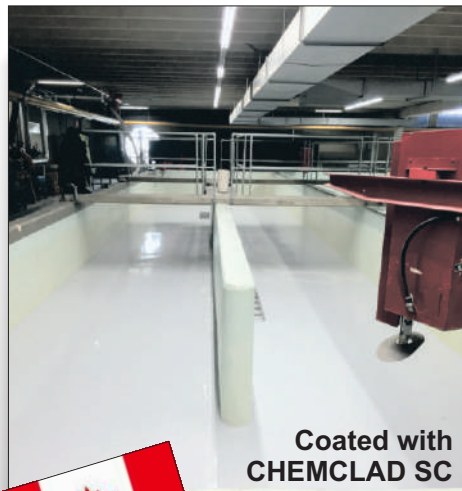
Coated with CHEMCLAD SC

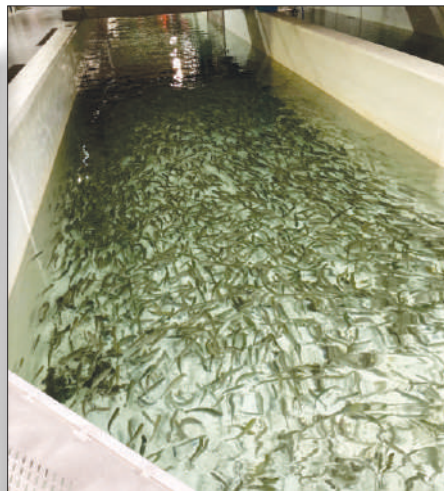
This trout hatchery in Western Canada is used to raise fish for lake stocks in the surrounding area. Pools like this hold the trout fry until maturity and then they are released into lakes. One of these pools was having filter drainage issues. The local ENECON Distributor was asked to help with a new filter drain installation and pool interior protection.

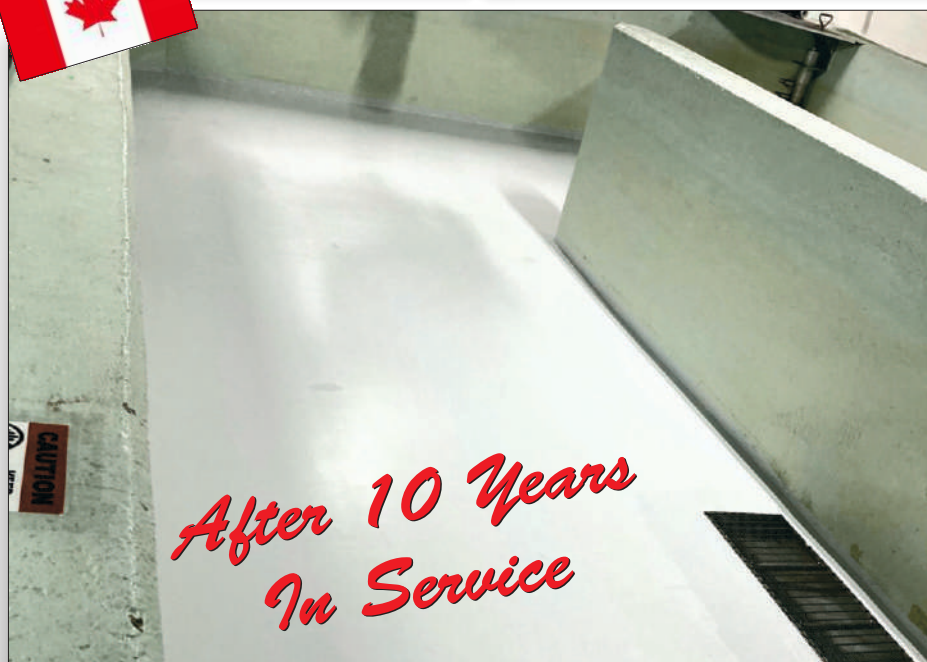
After ten years in service with only minor touch-ups and cleaning, the pool floor is in excellent condition. So much so that the hatchery decided to have the rest (20 more) of their pools protected the same way.

*After 10 Years  
In Service*
