## Historic Tennessee Church Now Used As Recording Studio Repairs Deteriorating Steps With ENECRETE & CHEMCLAD

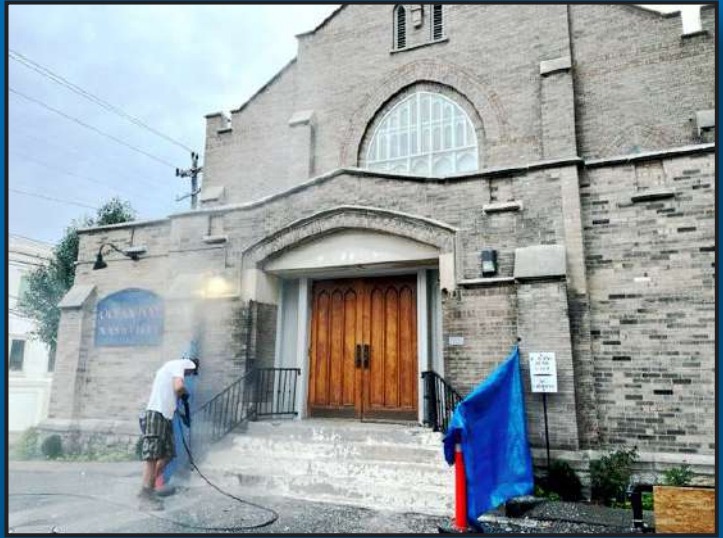
A university in Tennessee is home to a historic former church that is now a popular recording studio. The limestone front steps of the studio have cracked and crumbled over time to the point where they were a safety concern as well as an eyesore.

The university called in the Exclusive ENECON Distributor for Tennessee to provide a solution to this problem. The steps were first pressure washed which removed any previous coatings and loose debris.

Any damaged areas were repaired with *ENECRETE DuraQuartz*. The repaired areas were smoothed out manually with a grinder.

The steps were then coated with two coats of *CHEMCLAD GP* with a very fine pumice grit back-rolled in for added slip resistance.

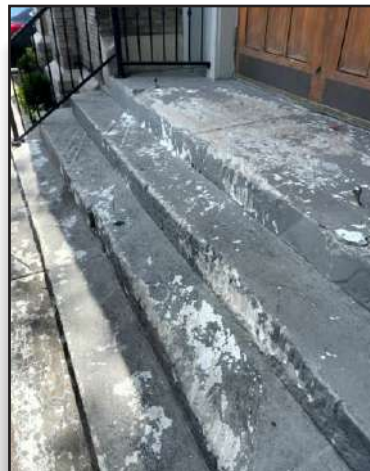
*Before*

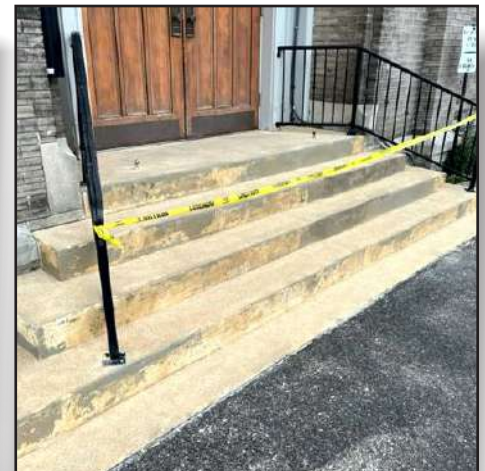
*After pressure washing*

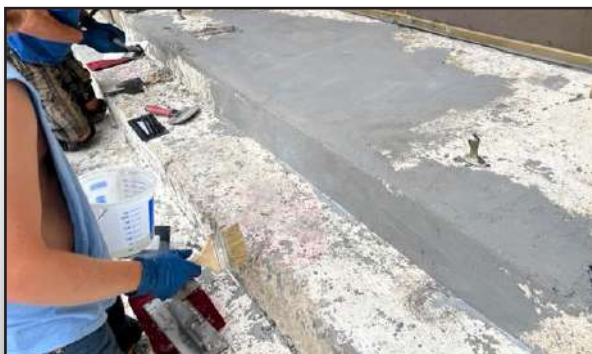
*Damage repaired with DuraQuartz*

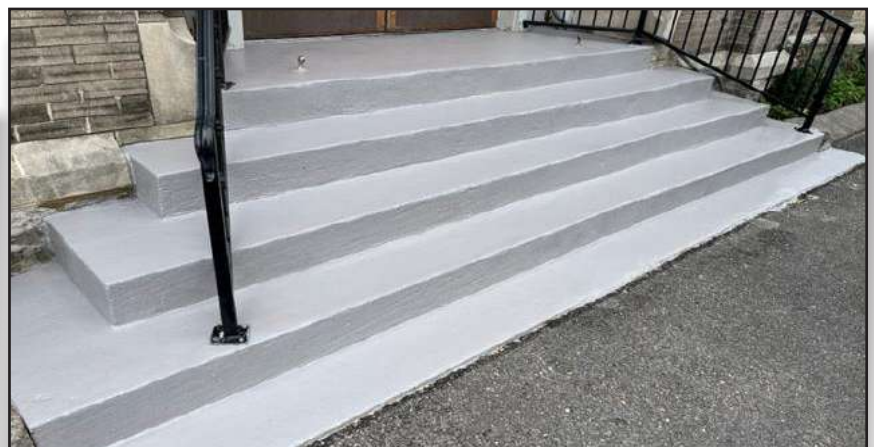
*Completed project*
