## Wastewater Treatment Dept. At Florida Nuclear Plant Refurbishes Clarifier Digester Tank With METALCLAD, CHEMCLAD & ENESEAL

The wastewater treatment department of a nuclear power plant in Florida needed to repair a combination steel clarifier / digester tank that held raw sewage.

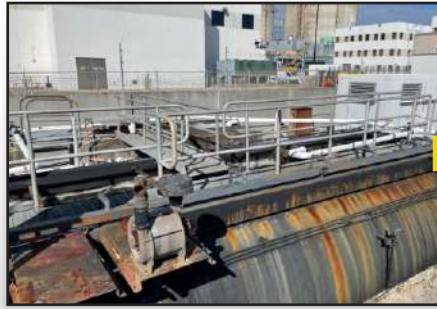
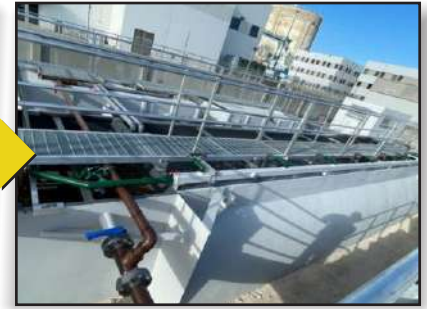
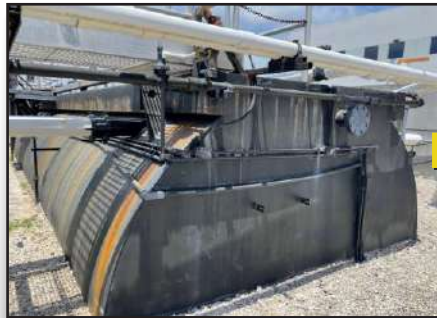
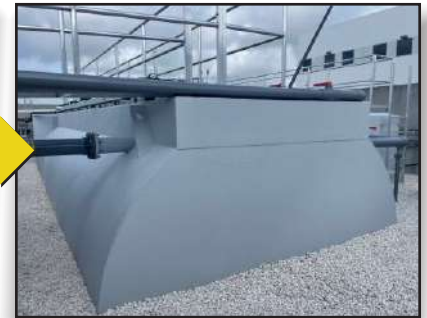
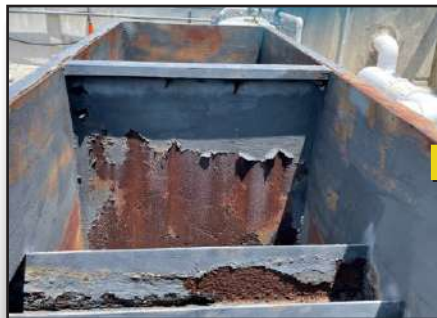
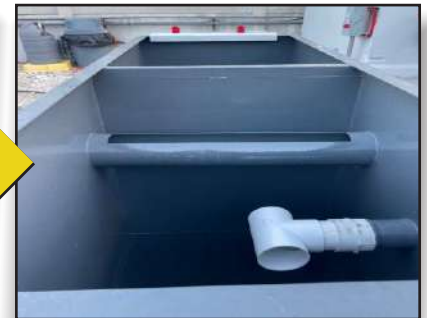
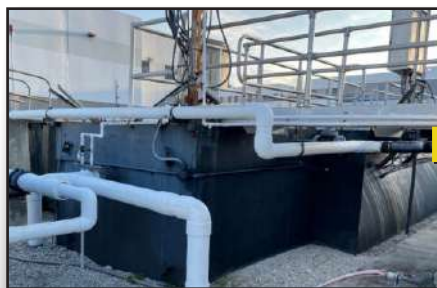
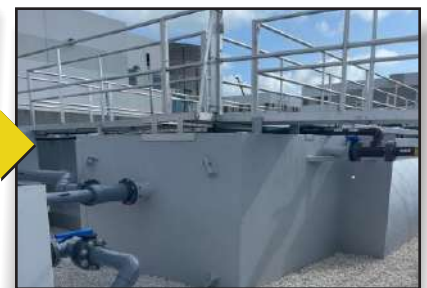
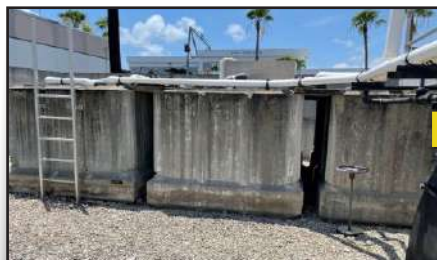
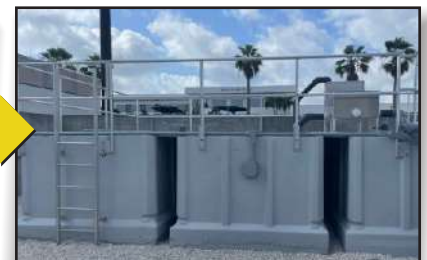
Measuring 12' x 40' and partially buried, the inside of the tank had severe corrosion damage. The maintenance team contacted the local ENECON Field Engineering Specialist to recommend a solution to this problem that needed to be solved quickly and on a budget.

After the tank was drained and cleaned, the inside of the tank was grit blasted. Some welding repairs were made followed by some repairs made with *DurAlloy*.

Two coats of *CHEMCLAD GP* were then used to protect the inside of the tank, providing chemical resistance in that harsh environment. The outside of the tank was given three coats of *ENESEAL CR*.

The tanks were cleaned with a high pressure washer followed by three coats of *ENESEAL CR*. The concrete tanks were the finishing touch on an extremely successful 'ENECON to the rescue' application.
