Acid & Caustic Pump Bases Rebuilt With DuraFill & Protected With CHEMCLAD At Aluminum Plant In United Arab Emirates

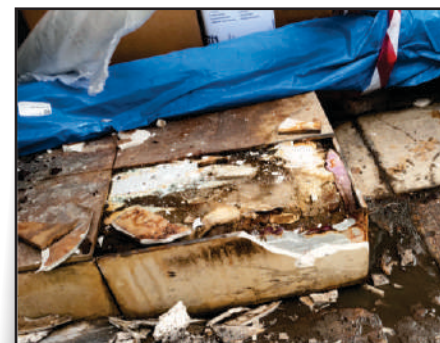
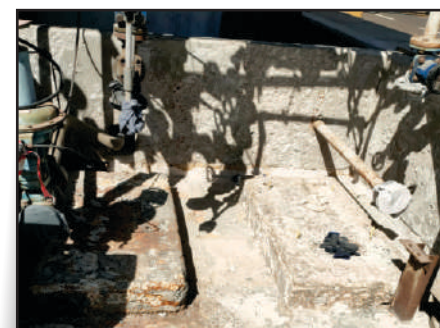
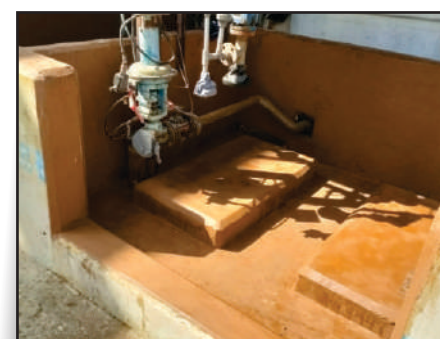
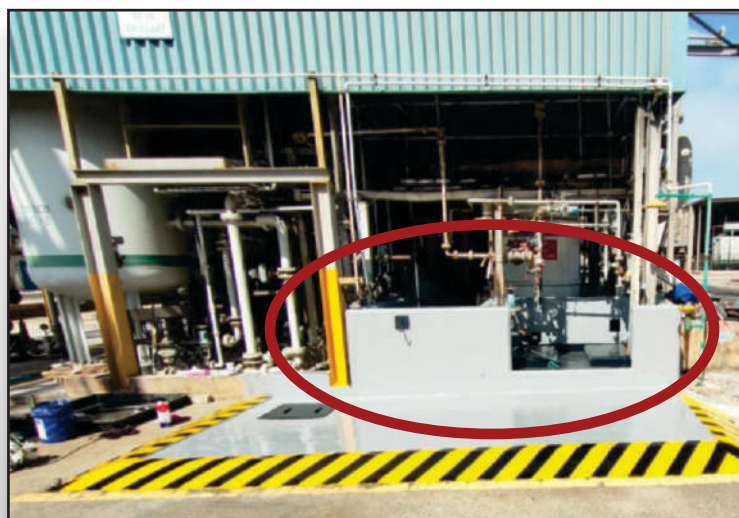
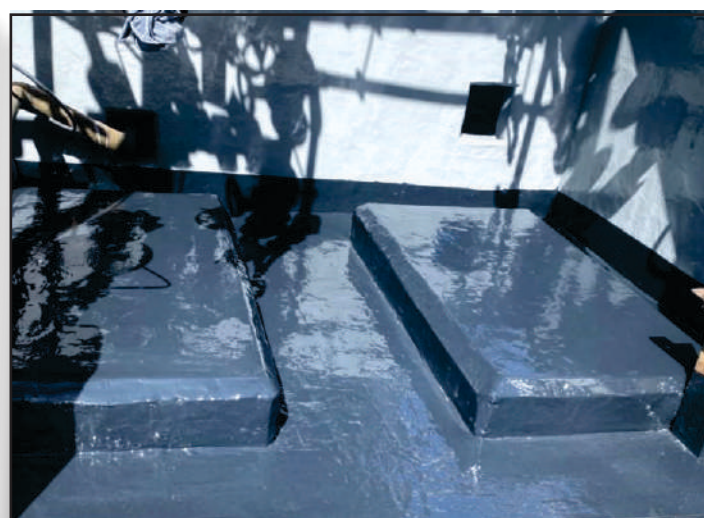
An aluminum plant in the U.A.E. was experiencing severe corrosion issues that needed special attention. Located in the demineralizing area of the aluminum plant's power plant, these concrete and ceramic tile covered acid and caustic pump bases were severely corroded and needed to be repaired and protected.

Leakage over 30 years from the pumps was able to penetrate the tile joints and damage the concrete below. Pouring new concrete in this area was not an option.

The entire area was first cleared of any loose concrete and tile then abraded by hand, vacuumed and any remaining residue was cleaned off the surface using a solvent.

After the application area was fully prepared, DuraFill mixed with a locally sourced aggregate was used to rebuild the pump base structures.

Two coats of CHEMCLAD XC were then applied to protect the newly repaired pump bases and the floor area of the entire pump enclosure.

CHEMCLAD GP was also applied to the walls as well as the floor next to the pump enclosure to prevent any issues in the future.
