Pharmaceutical Facility Restores Leaking Shower Stall With CHEMCLAD

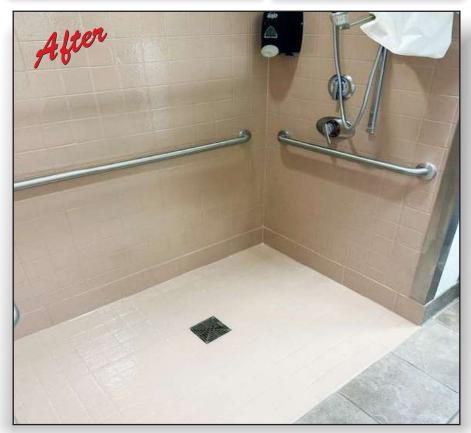
A major pharmaceutical company was experiencing persistent water leaks from shower stalls located above a room containing high-value processing equipment. The original tiled floor and wall grout had deteriorated, allowing water to migrate through cracks and joints. Traditional repairs had already failed, and shutting down equipment below was not an option.

After removing loose grout and cracked tiles and thoroughly preparing the substrate, the shower stall was resurfaced with a CHEMCLAD GP system, which performs ideally in wet environments such as this one. The CHEMCLAD sealed all tile joints, created a seamless, long-term, waterproof barrier, and restored the surface to a clean, easy-to-maintain finish.

The repair was completed in two days, and the stall was returned to service with minimal disruption. More importantly, the facility engineers could trust that the critical processing equipment on the floor below would be safe.
