## Hospital Entry Staircase Is 'Healed' With DuraQuartz & DuraFill

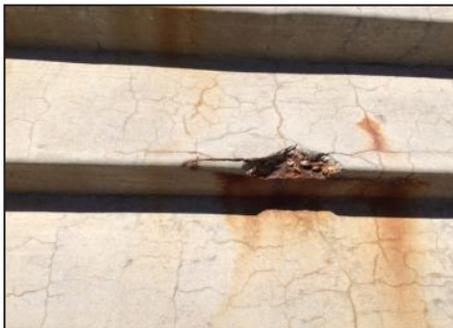
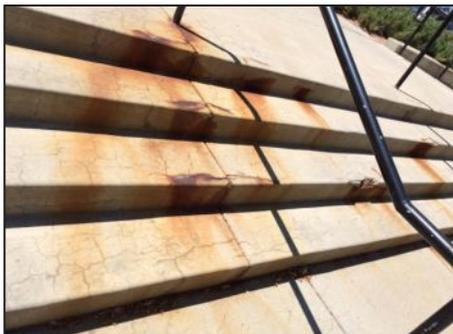
This application remedied the public safety hazard but it was an aesthetic improvement referred to as "better than 100%" by the client. This staircase is now an area of pride.

The stairs were first cleaned with lemon juice to remove the staining. Then DuraQuartz was used to repair the stair noses and voids in the concrete. Seams and expansion joints were taped and three coats of a Durafill broadcast system were rolled out.
