## ENECON's DuraQuartz RR Puts Hospital Parking Garage Back In Service In Just 45 Minutes

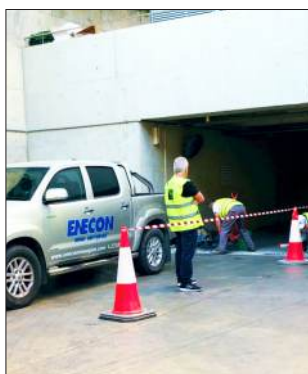
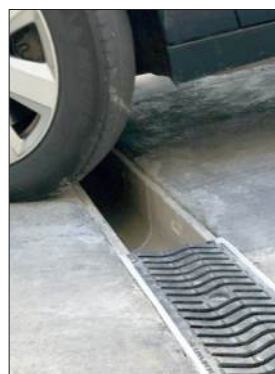
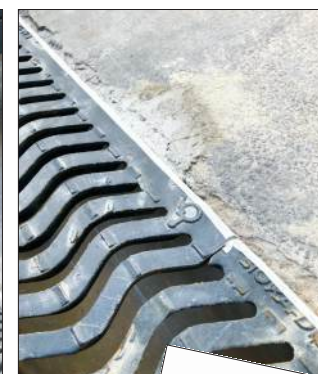
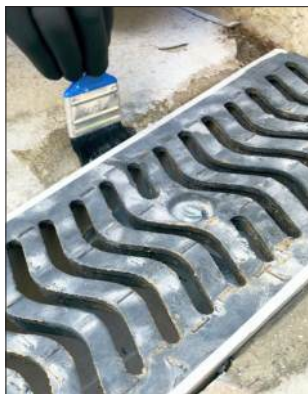
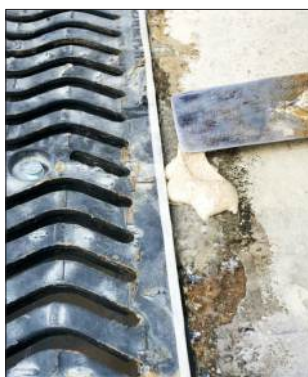
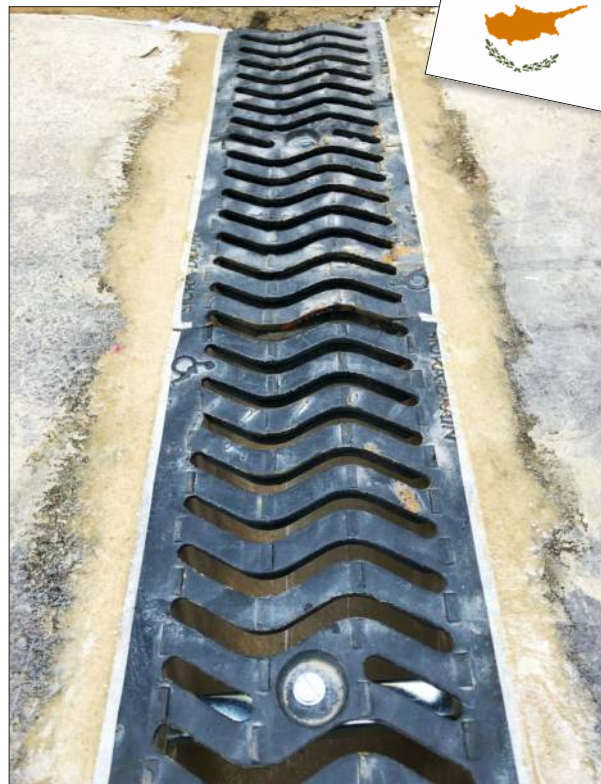
In Cyprus, the entrance to a hospital's multistory parking garage had severe concrete damage along its in-ground drainage channel from years of heavy vehicle traffic in and out of the garage.

Because of the damaged concrete, the channels were leaking to the parking level below. This needed to be fixed with minimal disruption to the hospital's busy parking garage entrance.

The damaged concrete surrounding the drainage channel, approximately 80 linear feet, was first removed.

The area was primed with the DuraQuartz RR resins only. The supplied sand was then added and the DuraQuartz RR was then troweled evenly to match the existing concrete.

It was decided ENECON's rapid return to service DuraQuartz RR would be used to rebuild the broken concrete along the channels.

Much to the delight of the maintenance team, this garage entrance was put back into service just 45 minutes later.
